Tornadoes - June 28th 2018

Damage Survey Results from Carter County, MT and Harding County, SD

Summary of Carter County Tornadoes

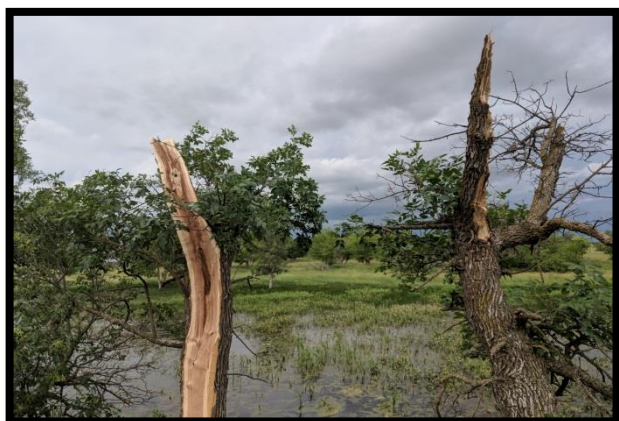
Around 7:17 PM the first tornado was spotted crossing SR 323 in Carter County about 12 miles north of Albion in the Finger Butte Area. This tornado was spotted by a rancher about a mile to the south. His property sustained straight line wind damage on the south side of the storm, including: trees uprooted, a barn roof blown off, a shed destroyed, and a horse trailer flipped over. This damage was consistent with winds 70-80 mph.

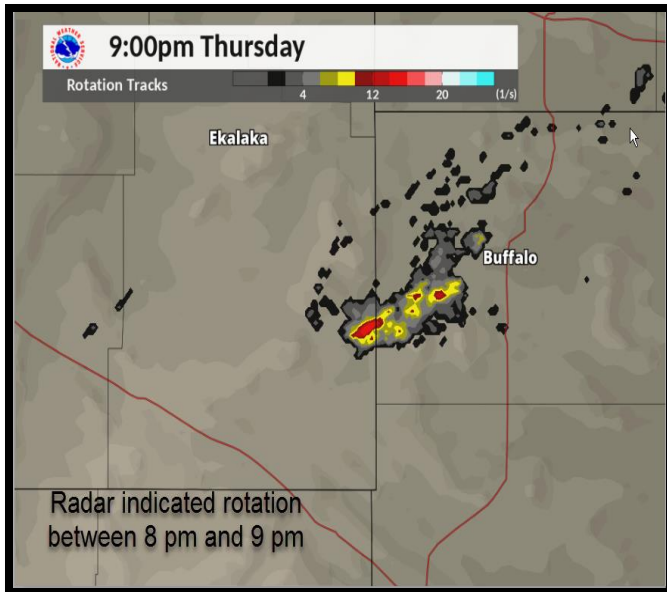
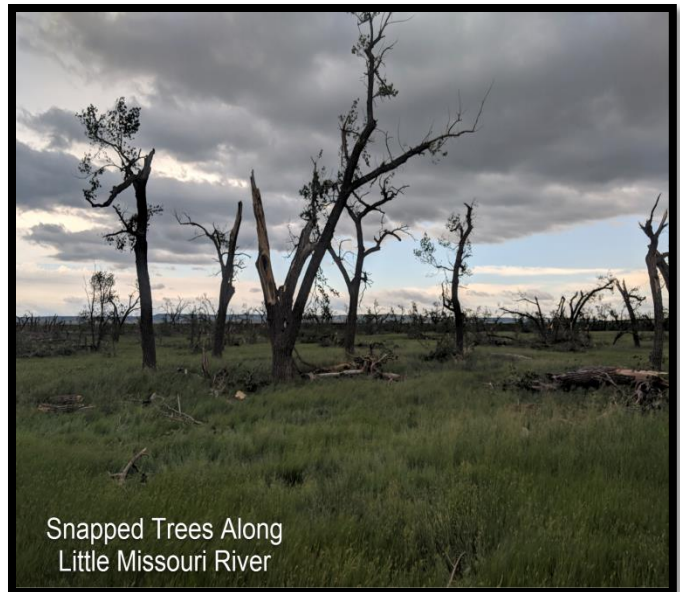
Damage survey and eye witness accounts confirm the tornado initially moved north-north-east along the Little Missouri River. As it approached the river it intensified to 120 mph (EF-2) producing an increasingly wider swath of snapped trees several hundred yards wide. The tornado started to turn more to the east at this time, moving on a northeasterly track as it crossed the Little Missouri and moved across the Montana/South Dakota border.

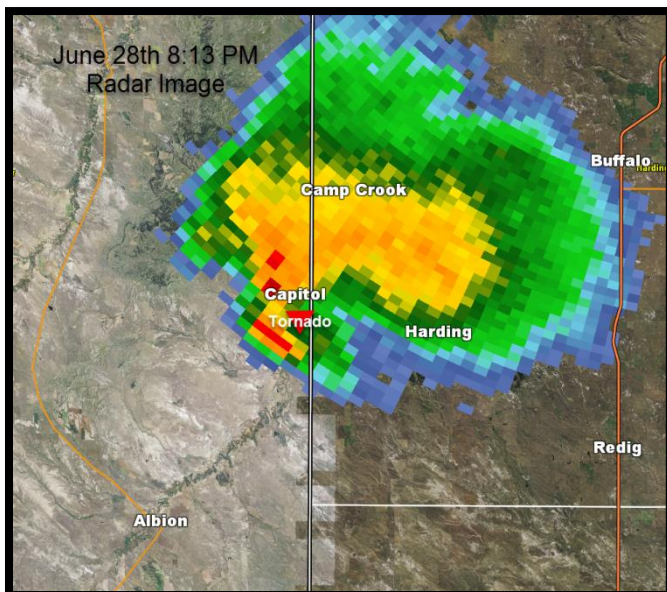
In South Dakota, this storm increased to an estimated ½ mile wide and damage observed was consistent with an EF-3 tornado rating, with winds estimated at 136 mph. Preliminary damage in South Dakota included one home destroyed, shed destroyed, trailer toppled over, heavy hay bales moved, along with tree damage (even debarked in some cases). Local residents reported finding numerous dead deer in the debris along the river where the tornado crossed the tree line. Damage in South Dakota is assessed by the National Weather Service in Rapid City and further updates to this information can be found at weather.gov/rapidcity.
