**Inside This Issue...**  
**Ice Breakup Flooding in May 2009**  
**End of 2009 Open Water Season**  
**Welcome New Observers**  
**Skilak Glacier Dammed Lake Release**  
**Start of Ice Thickness Measurements**  
**Record Warm and Dry July in Interior Alaska**  
**Salcha Flood Monitoring Network**  
**Highlights from the Alaska Center for Climate Assessment & Policy**  
**A Primer on Alaska River Gages**  
**In Search of High Water Marks - Stevens Village, Alaska**

**Alaska - Pacific River Forecast Center**  
**6930 Sand Lake Road**  
**Anchorage, Alaska 99502-1845**  
**<http://aprfc.arh.noaa.gov>**  
**800-847-1739**

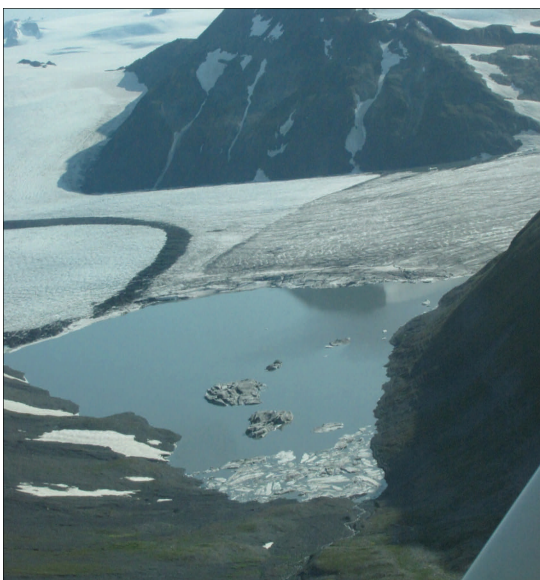
Skilak GDL; full of ice and water before release.  
Photo taken August 1, 2009 by Seward CAP.

Skilak Glacier Dammed Lake (GDL) drained earlier in the year than normal when it began releasing on or around August 8, 2009. Skilak GDL typically releases later in the fall, but it had not emptied since January 2007, when approximately 90,000 acre-ft of water was released mid-winter. This year, approximately 102,000 acre-ft of water drained from Skilak GDL and caused water levels on the Kenai River below Skilak Lake to rise above minor flood stage. River levels crested on August 17<sup>th</sup>, about 10 days after the release began. The gage below Skilak Lake recorded an increase of 2.5 ft and crested at 15.0 ft; the water levels crested at 12.5 ft in the Kenai Keys, and 12.0 ft in Soldotna. Minor flooding occurred in the Kenai Keys and Big Eddy areas. Roads were inundated with water, and yards and several garages were flooded, but no significant damage to household structures was reported. A special thanks to our observer in the Kenai Keys, Jim Jolin. We greatly appreciate all the information and extra river observations that Jim provided to us during and after the flooding.

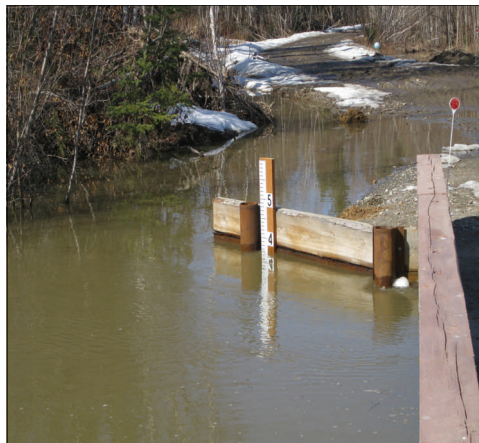
A new flood staff gage on Pile-driver Slough in Salcha helped emergency personnel and NWS forecasters respond to the 2009 spring breakup flooding.

Salcha, Alaska: this small community situated along the Tanana River about 30 miles southeast of Fairbanks has experienced chronic flooding in recent years. In 2008, the area was hit by significant ice jam flooding during breakup, and then again by heavy summer rains that brought near record flooding to the Tanana River. The complete lack of river gages on the Tanana River in Salcha has made it difficult to forecast, document, and compare the recurring floods. In the spring of 2009, the National Weather Service (NWS) in Fairbanks installed a handful of staff gages in the flood prone areas. Immediately after the installation, ice jams formed on the Tanana River, and Salcha was flooded once again. The usefulness of the new river gages became very obvious as the river began to rise. The gages served as an invaluable tool for monitoring the fluctuating flood waters by the NWS, emergency managers, Salcha Fire and Rescue, and local residents. The gages allowed many people to view and report changes in water levels from specific points within the community, which was extremely important for emergency response and evacuations. The addition of these gages will help to forecast and prepare for future floods in the Salcha area.

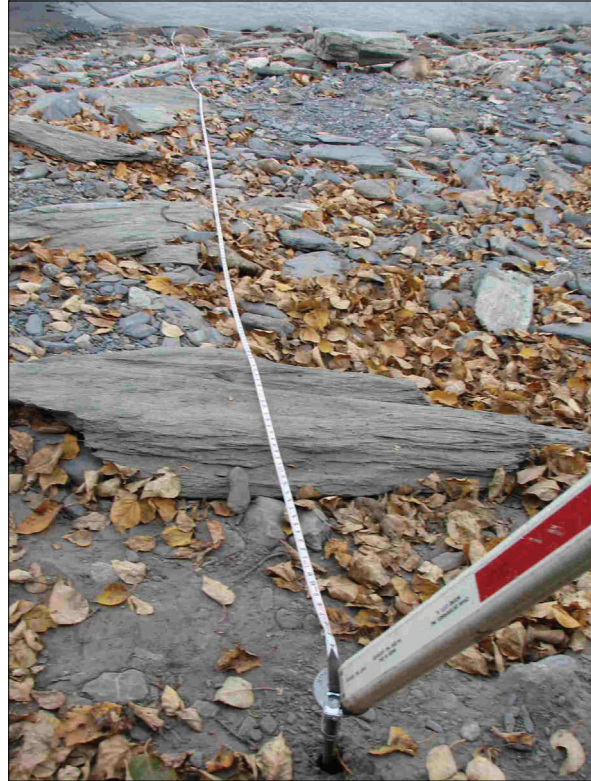
### Slope Profile Gages

When there are no bridges and no good place to put a staff gage, we use geometry to determine the river level. We survey the river bank, install several markers and determine the elevation of those markers, and survey the slope of the bank as far down into the river as we can reach. Our observers measure the distance from the marker down to the river's edge, following the same path that was surveyed. We use our survey information to calculate the elevation of the bank at the edge of the water. This type of gage works well if the bank is stable, but if the bank is eroding, it will need to be resurveyed frequently or the gage may need to be moved to another location. Most of the remote sites in the state have this type of river gage.

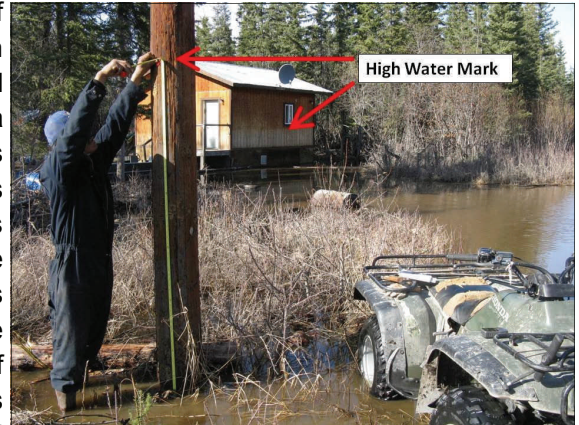
Documenting high water marks in Stevens Village on the Yukon River

I stood there amongst the massive chunks of ice trying to imagine the moment they were placed here. It was hard to comprehend the powerful force that had tossed them high up on the shore. Today, the Yukon River was more than 20 feet below me. This was not the scene three days before when the river was a raging torrent choked with a winters worth of ice that was plowing a path towards the Bering Sea. Anything near the riverbank was a potential victim of the catastrophe. The destruction was unbelievable; utility poles had been split apart like match sticks; cabins were lifted from their foundations; all that was left of some structures was a chaotic pile of logs; the belongings of people's lives were scattered about throughout the village. It was a sad situation and my thoughts went out to the residents that call this place home.

Stevens Village was essentially a ghost town. All women, children and elders had been evacuated before the floodwaters hit. Only a few men had remained to protect what they could and were now here cleaning up the aftermath. It was uncertain when it would be safe for the bulk of the population to return to their homes perched above the mighty Yukon River. I was here to record and document the crest of the high water. I carefully maneuvered around the debris laden village in search of clues that would indicate how deep the floodwaters were just a few days ago. Some signs were obvious, like a moist water line still visible on a cabin wall or a debris line of leaves and silt on the few remaining utility poles. In other places it was impossible to find any mark left behind by the high water. It is important to mark, photograph, and later survey the crest of the floodwaters in order to compare this event to past floods, as well as determine a safe building height for any future development. The flooding along the Yukon River during breakup 2009 was some of the worst in recorded history at some locations. Here in Stevens Village, it is estimated that this flood will go down in the record books as the 2<sup>nd</sup> highest on record.

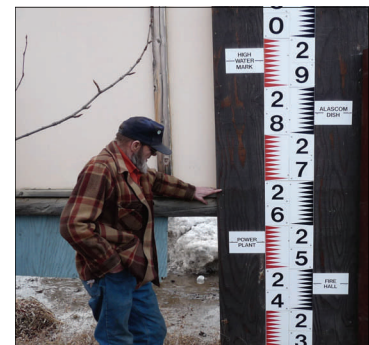
Dick Hutchinson of Circle points out a high water mark caused by flooding during this year's breakup

Getting an estimated peak level during breakup at slope profile gages can be very difficult due to ice on the banks at the gage location. If you can see the high water line on the bank anywhere near your gage site and can mark that location with a spike, this mark can be measured after the ice melts away or surveyed by NWS staff during a field visit.
