Mendenhall Valley Jökulhlaup Flood Event

Alaska - Pacific
River Forecast Center
6930 Sand Lake Road
Anchorage, Alaska 99502-1845
<http://aprfc.arh.noaa.gov>
800-847-1739

**Mendenhall Valley Jökulhlaup Flood Event
by Aaron Jacobs**

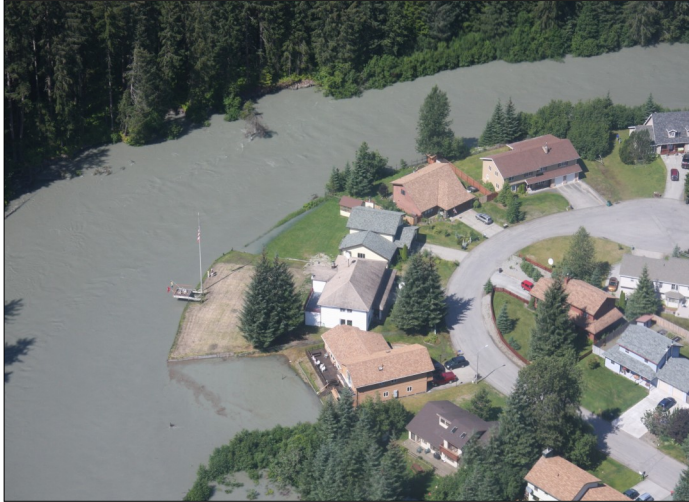
Flooding along the Mendenhall River below the Back Loop Bridge

- The Mendenhall Campground was evacuated.
- A sub-division that lies next to the Mendenhall River was evacuated because the road leading to the sub-division was flooded and impassable, one home in that sub-division flooded with up to 3 feet of water.
- The Skaters Cabin Spur Road near Mendenhall Lake also flooded with about 2.5 feet of water.
- Residents below the Back Loop Bridge along the Mendenhall River had flood water in their back yards.

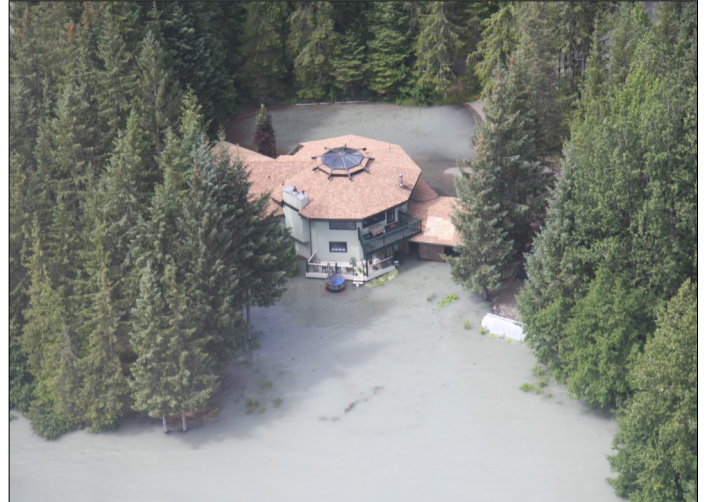
Flooding along the Mendenhall River at View Drive

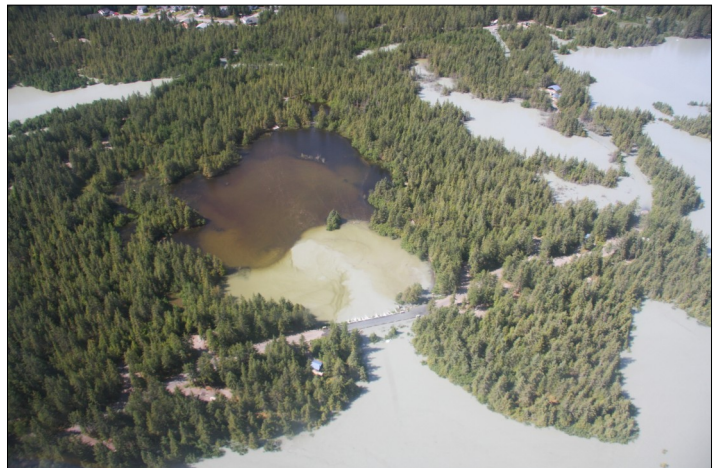
Flooding of the Mendenhall Campground

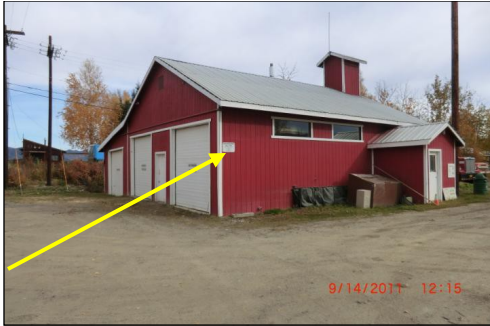
High Water Mark sign on the fire hall in Eagle to commemorate the devastating Yukon River ice jam flood in May 2009

The National Weather Service has teamed up with the US Army Corps of Engineers (COE) to install high water mark signs in several Alaska communities. These small placards identify the water depth and date of the record flood for the community. The signs are being placed in highly visible locations in order to bring awareness of flooding to the local residents and visitors. The first sign was installed at Crooked Creek on the Kuskokwim River to observe the record breakup flood last spring on May 8, 2011. Signs were also hung on the fire hall and Laundromat in Eagle to commemorate the devastating Yukon River ice jam flood in May 2009. Additional signs will be placed in other communities in years to come.

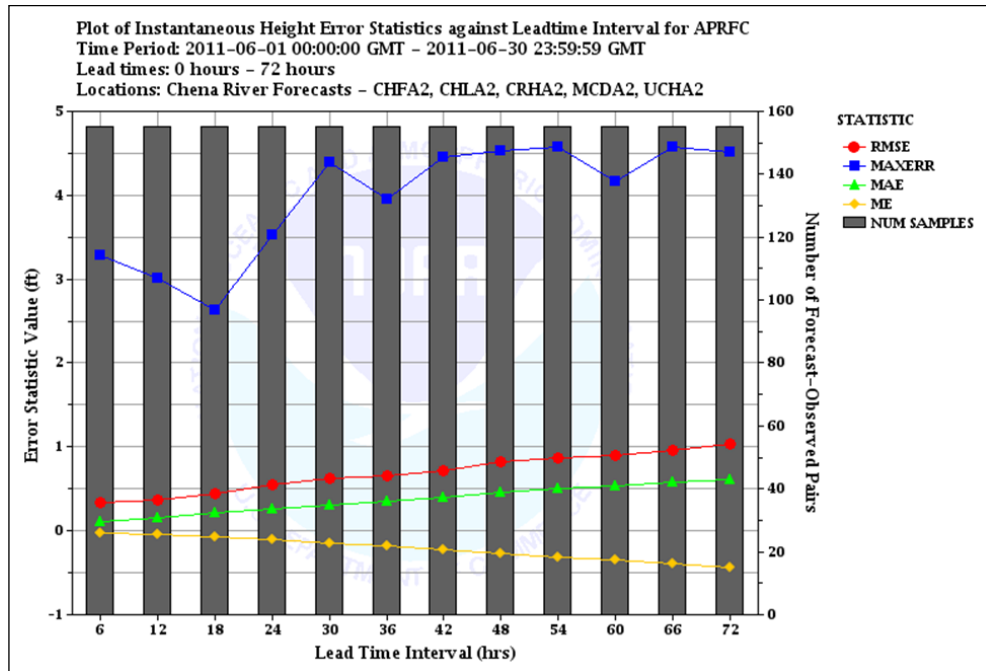
Another use for verification is to compile error statistics over various hydrologic forecast horizons to provide a measure of forecast uncertainty as a function of the how far in the future the forecasts were made. This could provide a quick estimate of uncertainty to forecast users, and indicate how much confidence to incorporate into future forecasts. These types of statistics, along with others, start to define a measure of skill in our forecasts. See example next page:
