Kuigmek: from the river

January 2024

Alaska-Pacific
River Forecast Center

Focus on: 2023 Breakup Summary - Crooked Creek

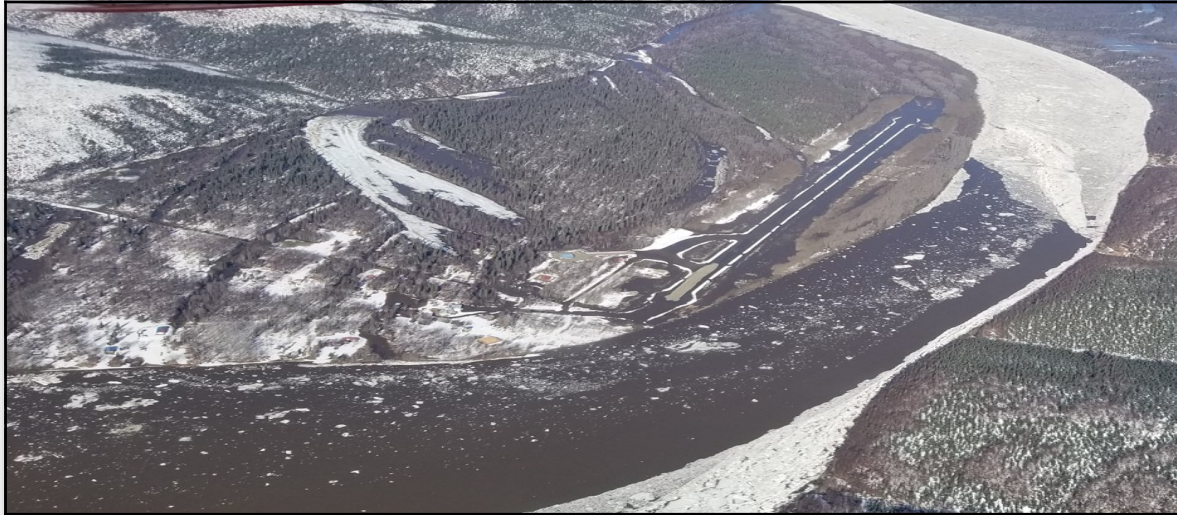
Figure 1: Aerial view of Red Devil showing extensive flooding to the runway on the morning of May 13th.

The Kuskokwim River Watch team activated and started daily reconnaissance flights on May 8. Even this late into May, the ice was still strong and in place. The communities of Stony River and Sleetmute broke up on May 12 with no significant ice jams or flooding. The breakup front advanced downriver, and on May 13, a large ice jam formed just downstream of Red Devil, backing water into the community and flooding the runway and

several structures. Local observers reported that the ice jam formed earlier in the morning with rapidly rising water levels. This ice jam was only in place briefly; the breakup front progressed downriver, and flood waters receded on May 13 at Red Devil.

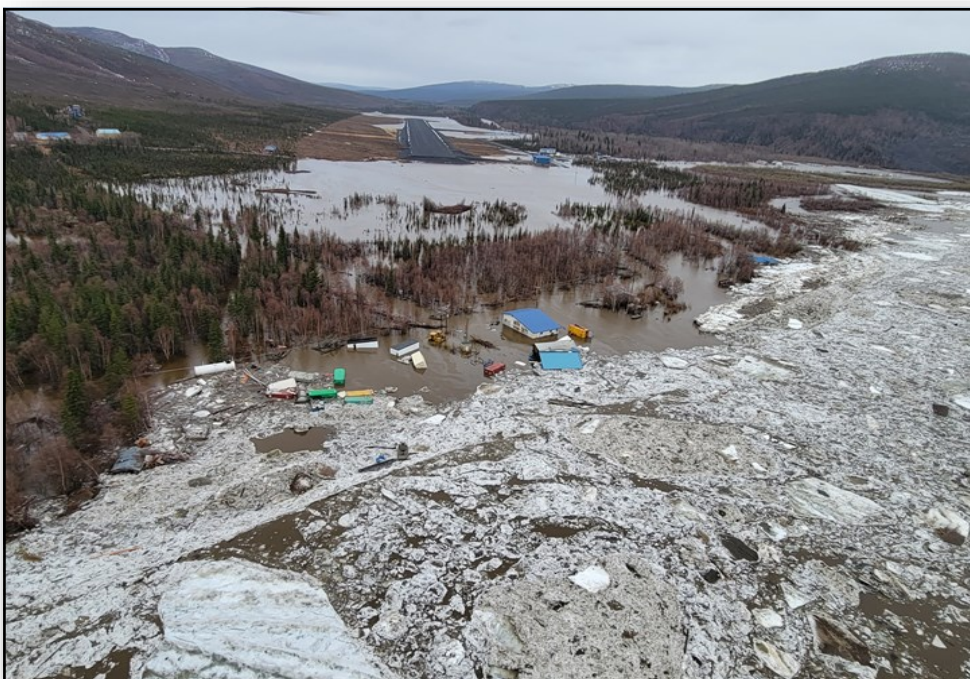
Figure 2: Aerial view of Crooked Creek flooding on the morning of the 14th, captured just after the river crested.

The River Watch team landed in Crooked Creek to relay the upriver ice jam information and local river conditions, briefing the community on the possibility of ice jamming and rising water. The ice jam formed downstream from Crooked Creek late on May 13 near Rabbit Island.

Water levels quickly rose tens of feet, flooding up to the second story of numerous buildings and forcing residents to evacuate uphill to the school. Aerial flights in the morning of the 14th confirmed widespread flooding in the community, with overbank ice and portions of the town cut off due to flooded local roads. Fortunately, the runway remained above the floodwaters and allowed for coordination and access for flood response.

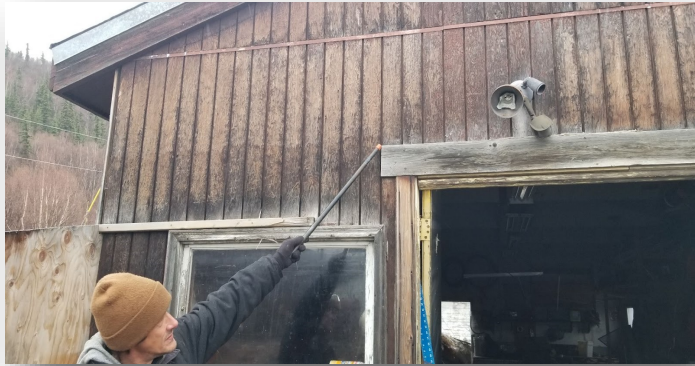
Figure 3: A Crooked Creek resident pointing to the high water mark on his garage.

The USGS maintains a river gage on the Kuskokwim River at Crooked Creek. The gage has been operating since 1951. The USGS estimates the crest river stage to be 32.4 feet, the highest on record at this location since the gage began operating. The last major flood at Crooked Creek was in 2011, with a water level of 32.0 feet. In August, a Federal Disaster Declaration for the Spring 2023 flooding was approved, with disaster assistance made available to the State of Alaska to supplement state, tribal, and local recovery efforts in the areas affected by flooding. This declaration included Crooked Creek and other communities along the Kuskokwim River (<https://www.fema.gov/disaster/4730>).

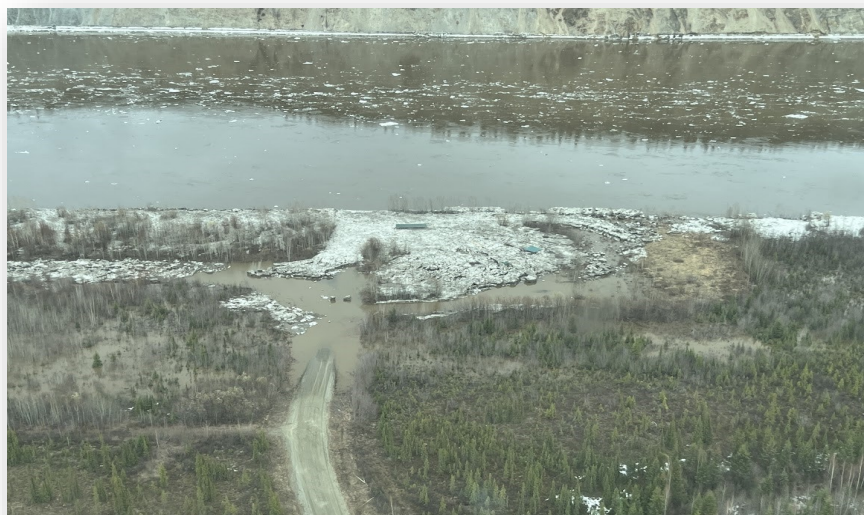
Figure 5: Moderate flooding in Eagle pushed ice overbank covering the access road between Eagle and Eagle Village. This took several days to clear.

The Fortymile ice arrived at Eagle late in the day on the 12th, flooded several buildings, and deposited ice on the road between Eagle and Eagle Village that limited access and took several days to remove. After Eagle, the breakup front kept moving - an observer 28 miles upriver of Circle reported the highest water they had ever seen at their cabin. On May 13, the Riverwatch team observed widespread flooding (trees inundated, islands covered in ice, river well out of bank) upriver from Circle. When the ice started running at Circle on May 13, the breakup front had a 90-mile-long ice run behind it.

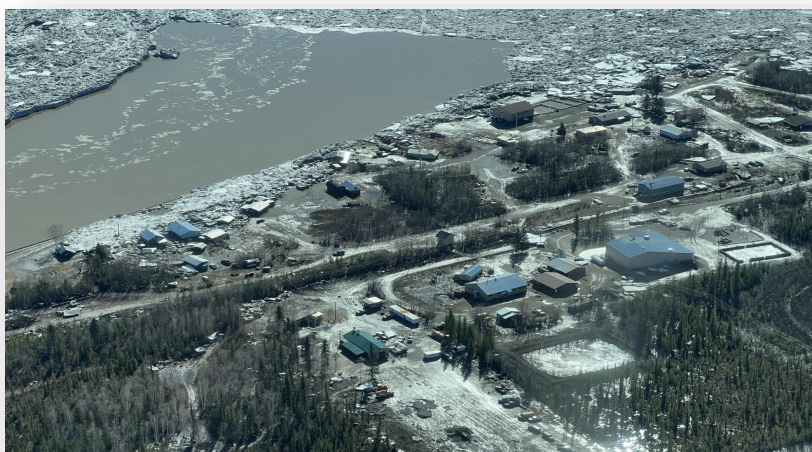
Figure 6: Stranded ice and floodwaters on May 14th in Circle. In addition to the flooding, the water had lifted and shifted some buildings off their foundations.

Flooding in Circle occurred quickly; the water rose extremely fast, and major flooding was first reported around 8 pm. Overnight, there was extensive damage, with flood waters likely higher than the previous flood of record, 1945. Most structures in the town flooded; the store had water up to the first floor's ceiling, and the airport apron and taxiway were flooded. Ice was stranded along the waterfront throughout the community. By the following day, floodwaters had receded and dropped below the airport access road by 3 pm May 14.

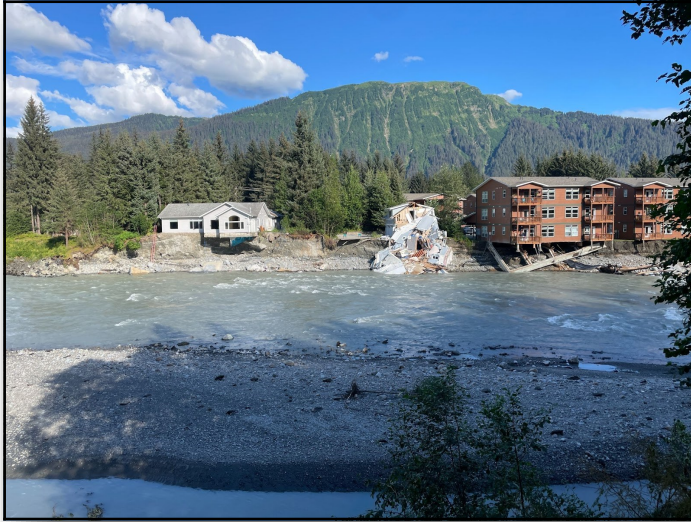
Figure 10: Mendenhall River looking at Riverside Condos, a house that fell into the river, and a major damaged house.

On August 5th, 2023, the Mendenhall River in Juneau flooded, cresting three feet above any previous record. This flood caused significant flooding and erosion along Mendenhall Lake and River. From the flooding alone, several homes had six feet of water in them. The erosion took 20-150 feet of land in some locations, compromising multiple homes and an apartment complex.

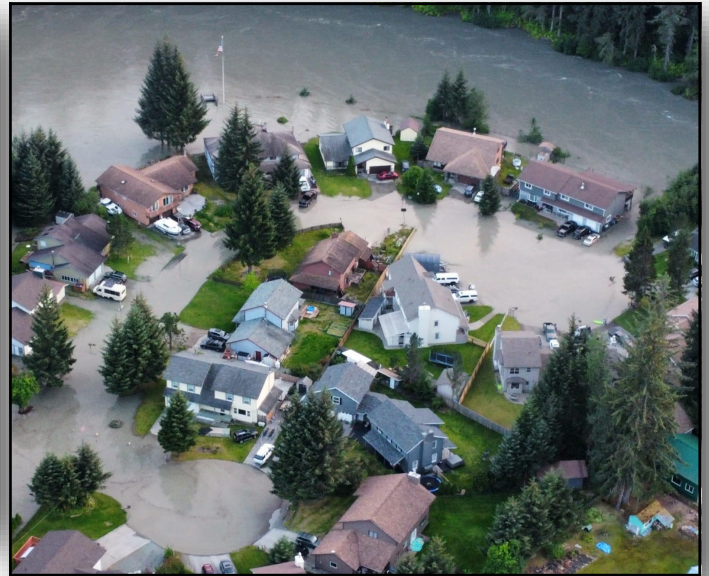
Figure 11: 9 PM August 5th on Meander Way in Juneau.

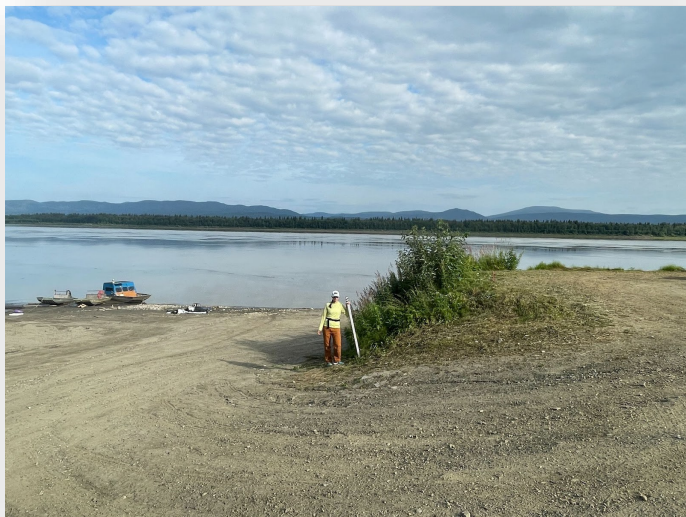
Figure 14: Celine preparing to survey new slope profile at Ruby.

- The Middle Yukon River had a dynamic breakup. Water levels at Ruby were the second highest in recent memory and caused significant bank erosion at the slope profile location used over the past 3-4 decades. Not only had the slope profile changed (so the computed stage would be incorrect), but it was no longer safe to access the river. An APRFC visit re-connected us with our long-term River Observer, re-surveyed for historical gage datum verification and slope profile, relocated the slope gage ~1500 ft downriver where access was safer, determined gage elevation referenced to NAVD88, and found a locally unknown wild strawberry patch (shh!).
