Kuigmek: one who watches the river

December, 2018

**Alaska-Pacific
River Forecast Center
6930 Sand Lake Road
Anchorage, AK 99502-1845
907-266-5160
1-800-847-1739
<http://weather.gov/aprfc>
nws.ar.aprfc@noaa.gov**

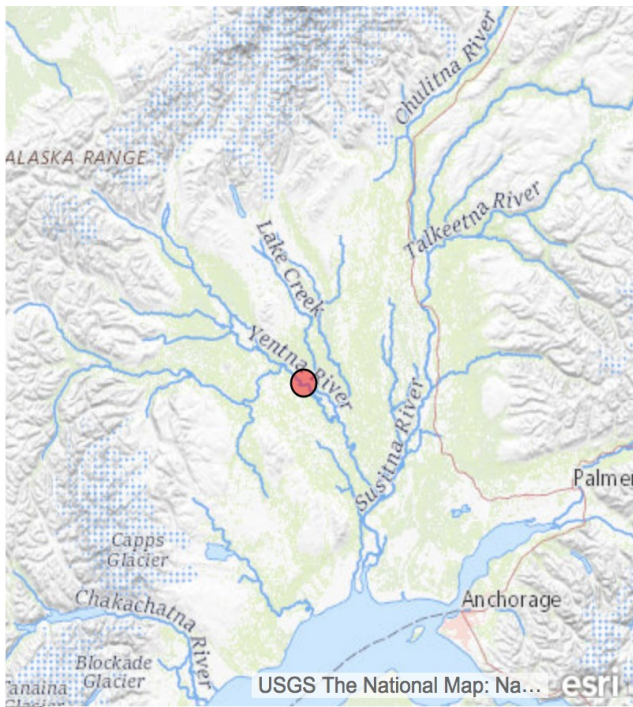
Figure 4: location of slope gage on the Yentna River near Lake Creek. National Weather Service at weather.gov/apr/c

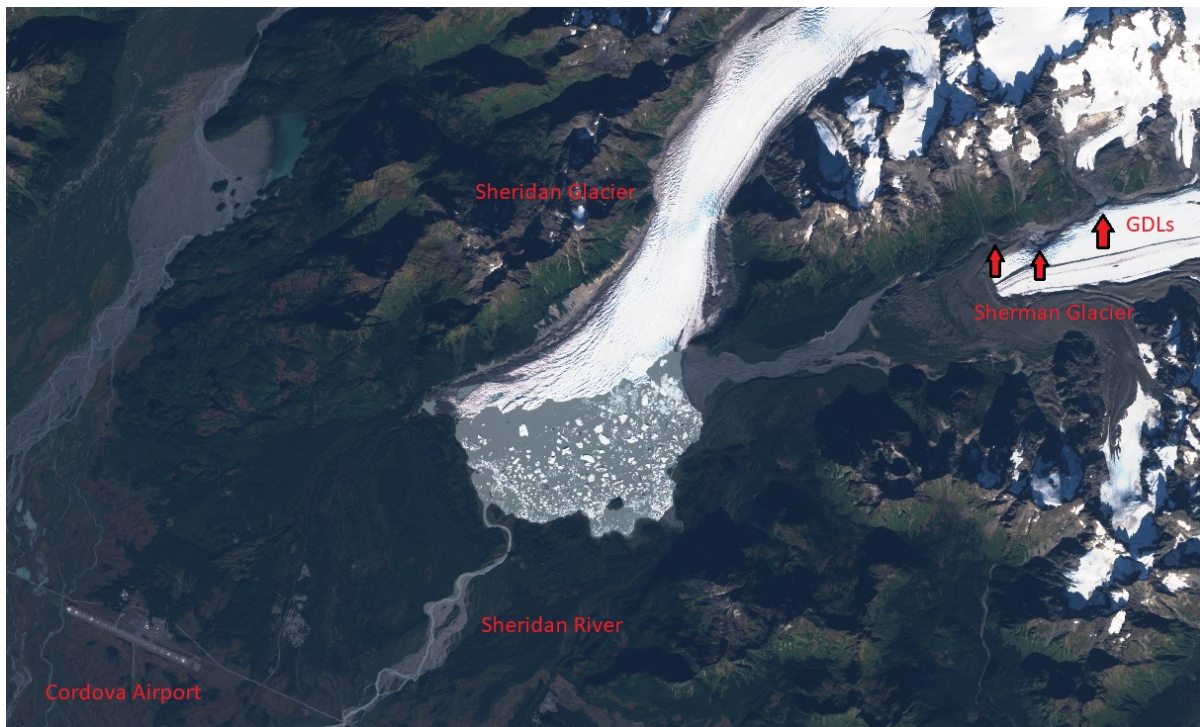
Figure 5: Sentinel-2 multi-spectral satellite imagery shows a series of glacial dammed lakes on Sherman Glacier. When one of these lakes lets go, the water ends up in the Sheridan River near Cordova.

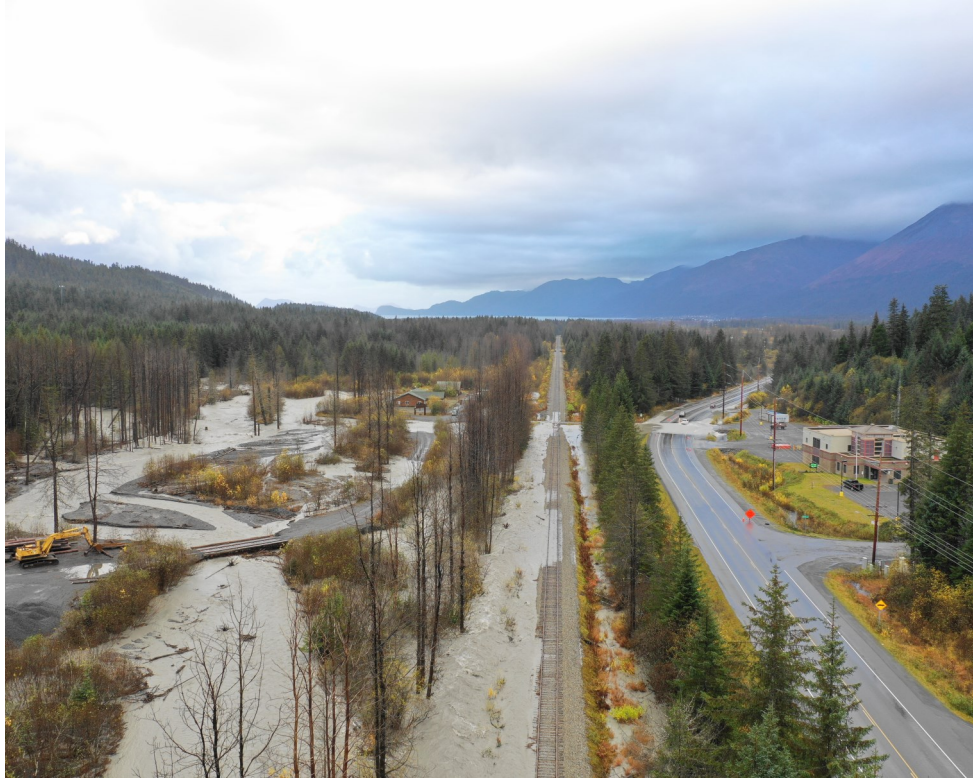
Figure 10: heavy equipment is helping preserve this bridge near Seward by removing gravel from the streambed as it's washed down by heavy rain. Photo courtesy of Alaska DOT&PF.
