Central Carter County Tornado Southeast Montana July 19th, 2019

The following information is based on NWS storm survey results.

Magnitude: EF-1 Location: 3 miles northeast of Ridgeway, MT 45.502719, -104.450348 Time: 12:44 am Winds: 86-110 mph Width: 100 yards Length: Half mile

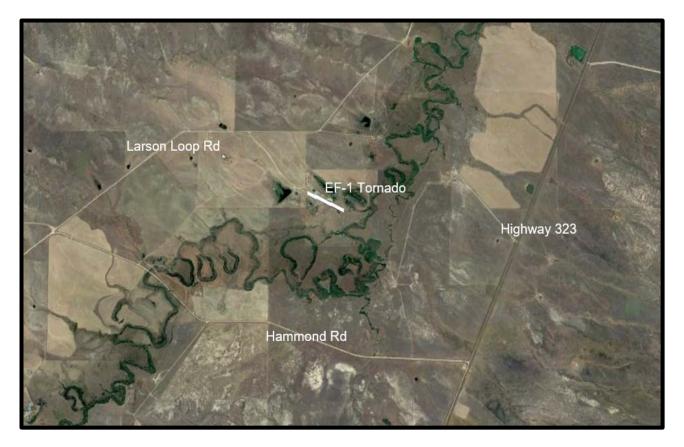
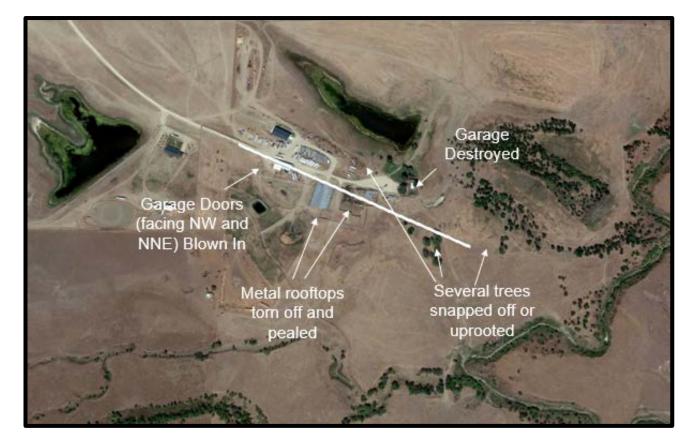
The following are maps that show the location, path and impacts of the tornado.

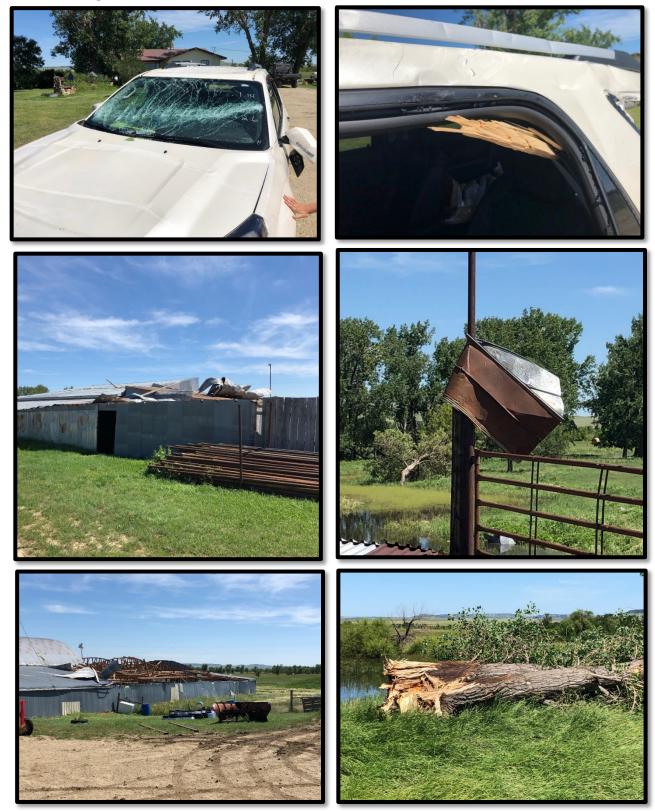
There was considerable damage to buildings on a local ranch. A shop building had 2 doors blown in and roof damage. Two other sheds had significant roof damage. Several metal rooftops were torn off and peeled back. A small garage was destroyed with a vehicle displaced inside, turned and moved by a couple feet. Several trees were snapped (approximately 1 foot diameter), with other smaller trees blown over or uprooted.
