# **SOUTHERN INDIANA FLASH FLOOD EVENT**

Sally Pavlow, John Hendrickson, David Sherrieb, Al Shippe  
National Weather Service Forecast Office  
Indianapolis, Indiana

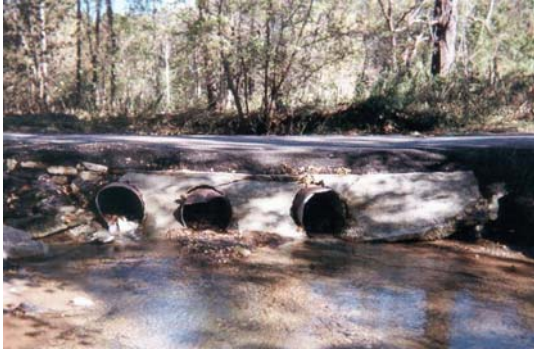
Fig. 7  
w

ter Crossing Prior To Mitigation

Terrain was the leading factor causing this tragic flash flood event. With the steep inclines and narrow creek, the amount of rain that the watershed took on was more than it could handle without jeopardizing human safety. The Monroe County Highway Department had targeted that particular low water crossing as a site for repair. According to the Highway Department's Highway Engineer, improvements of the crossing began one week after the accident occurred and were completed by the middle of January 2001. Figure 7 is a photo of the crossing before mitigation and Figure 8 is after mitigation. Although the crossing was known to be a hazard by local residents, this particular motorist was not privy to that information. As a result of this tragedy, the Monroe County Highway Department has identified all other low water crossings in their county and placed signs at those crossings to warn of the hazard.

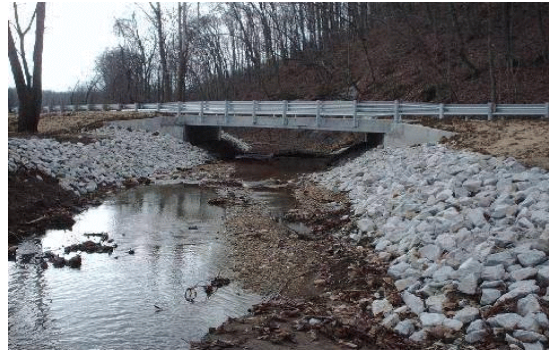
Fig. 8 Low  
ter Crossing After Mitigation
