2012 Southeast Louisiana and Southern Mississippi Flooding Due to Hurricane Isaac

W. Scott Lincoln<sup>1</sup>, Jonathan Brazzell<sup>2</sup>, Marty Pope<sup>3</sup>, Roger McNeil<sup>4</sup>, David Schlotzhauer<sup>1</sup>,  
Katelyn Costanza<sup>1</sup>, Jeffrey Grascel<sup>1</sup>, Suzanne Van Cooten<sup>1</sup>

33 **ABSTRACT**

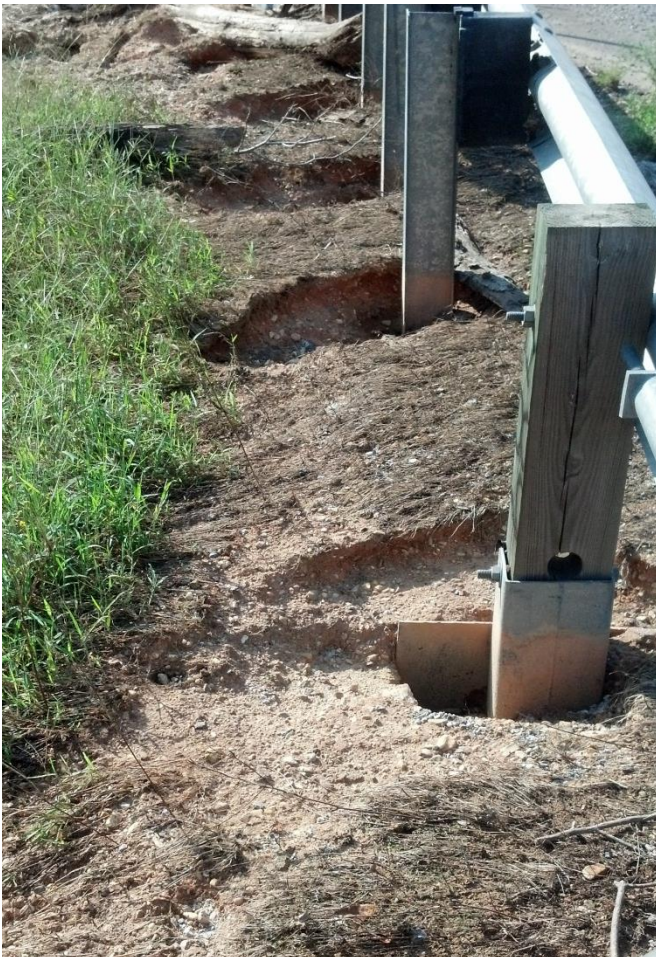
359 Widespread bent and snapped trees/brush were observed in the floodplain near the  
360 Silver Run Rd bridge. Evidence of damage was up to about 1.0 ft higher than the bridge deck.  
361 Scouring was noted on downstream side of bridge approach guardrails (Figure 14). Anecdotal  
362 evidence from an individual residing at the corner of Silver Run Rd and Oscar Lee Rd suggests  
363 that the flood elevation may have exceeded that of any flood since at least 1934.

364  
365 Figure 14. Guardrails on downstream side of the Silver Run Rd. bridge showing evidence of  
366 scouring.  
367

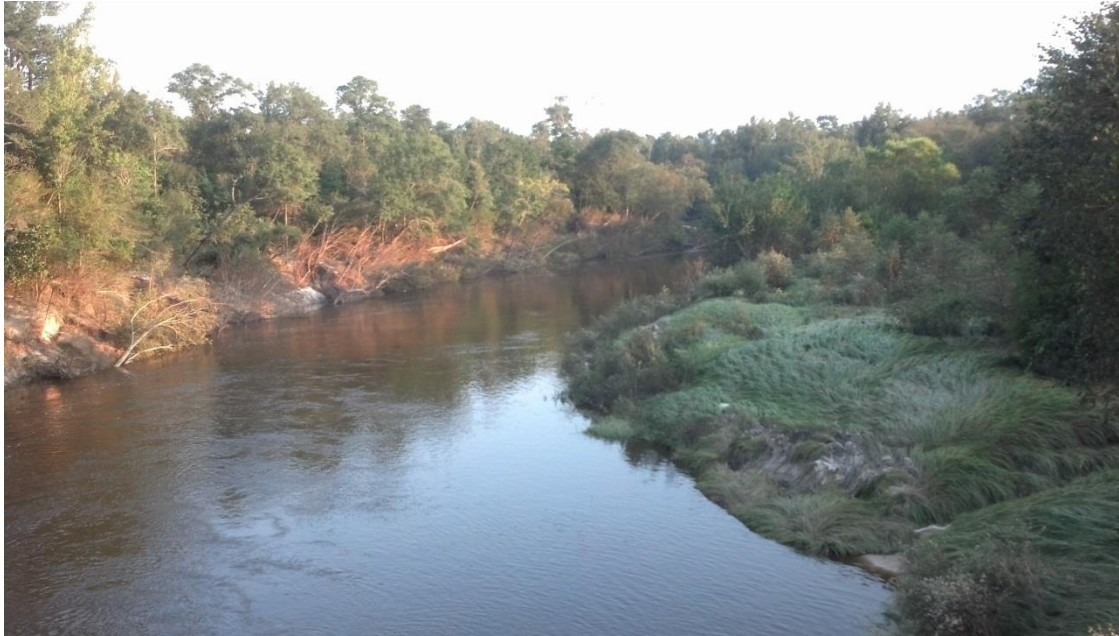
410 Widespread bent trees/brush were observed in the floodplain near the Cable Bridge Rd

419  
420 Figure 15. Downstream view from Cable Bridge Rd. Widespread damage to trees and brush  
421 were noted.  
422

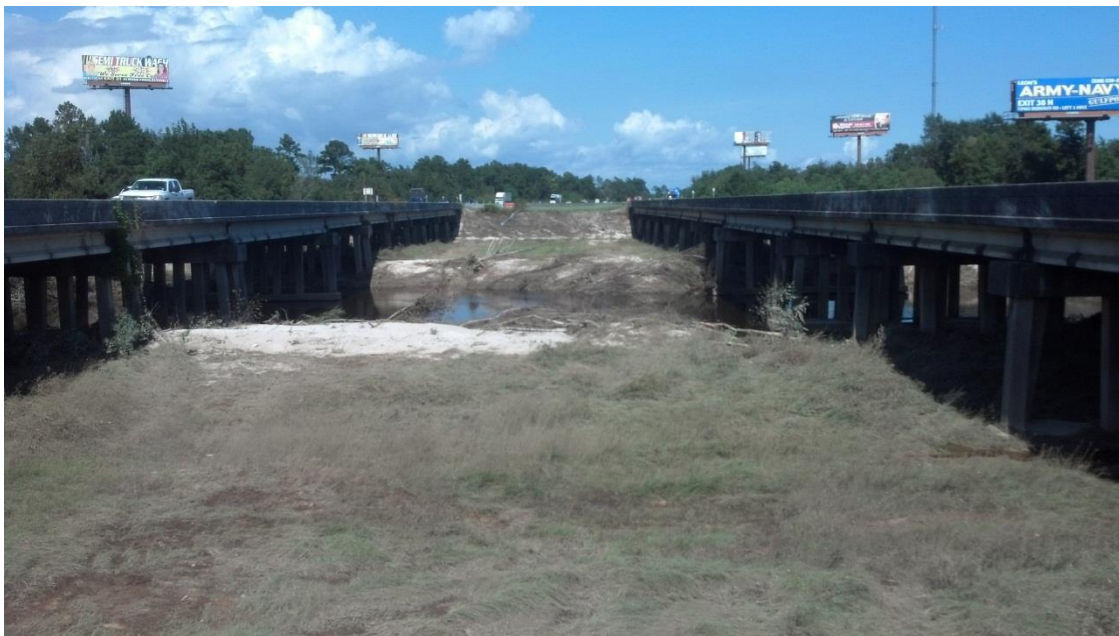
423  
424 Figure 16. Wolf River floodplain between the eastbound and westbound bridges of I-10.  
425 Widespread tree/brush damage was noted along with scouring of the overbank areas.  
426  
427

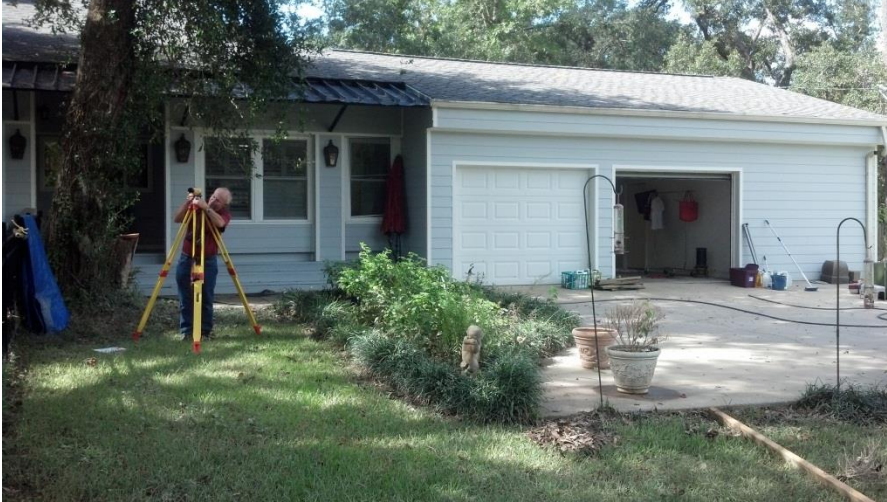
458 Home #3: The Montgomery home, the first house in on east side of Magnolia Dr.  
459 House had clearly visible high water mark in garage and in trees near river (**Error! Reference**  
460 **source not found.**). The crest stage of 16.0 ft was surveyed to the Harrison County staff gauge  
461 by using this high water mark. This crest estimate was consistent - within 1-3” - of another high  
462 water mark across the street, as well as anecdotal evidence provided by interviewed residents.

498  
499 Figure 17. The Montgomery home on Magnolia Dr. had a clear high water mark inside of the  
500 attached garage. Flood survey team members Marty Pope (pictured) and W. Scott Lincoln used  
501 this high water mark to help estimate the crest for the Wolf River at Bells Ferry Rd. (GLFM6)  
502 forecast point.  
503

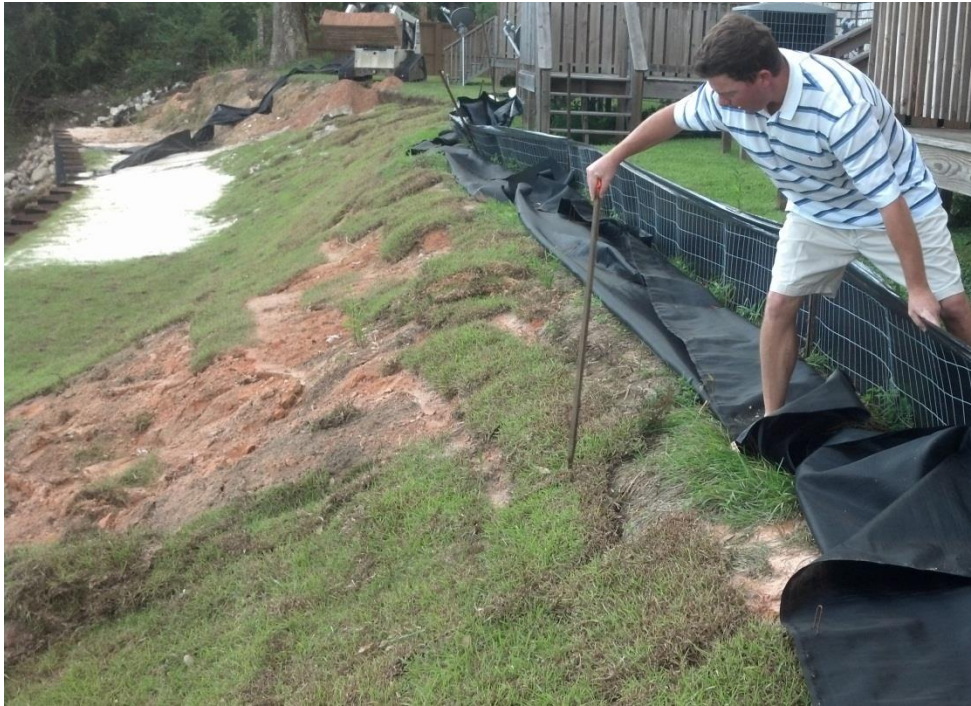
569 difference in elevations was noted between the elevation of the light pole (14.4 ft) and that of the  
570 riverbank behind the apartments (16.5 ft).

571  
572 Figure 20. Flooding from the Tchoutacabouffa River caused substantial scouring to the cut bank  
573 behind the Riverbend Cove Apartments just off Lamey Bridge Rd. Resident Wendell Green  
574 (pictured), who stayed during most of the flood event, indicated the high water level to the NWS  
575 flood survey team which they used to help estimate the crest for Tchoutacabouffa River at  
576 Lamey Bridge Rd (DIBM6).  
577

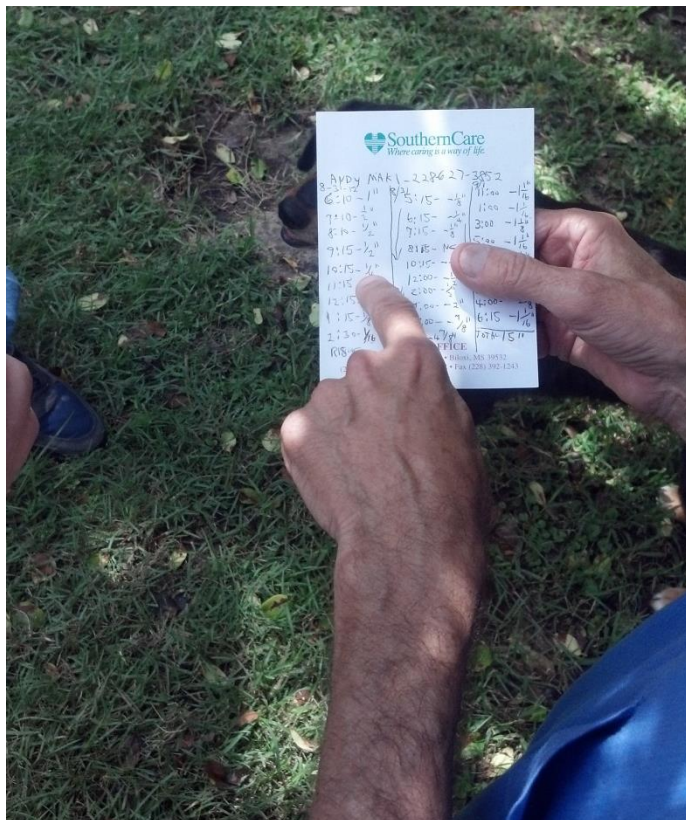
698  
699 Figure 23. Flooding from the Escatawpa River nearly affected the property of Thomas  
700 Marthaler. Mr. Marthaler made frequent note of the water elevation near his home and shared  
701 his observations with the survey team.

690 Home #1: Thomas Marthaler residence at the corner of Marthaler Rd. and  
691 Independence Rd. was visited by a survey team. Mr. Marthaler kept a personal record of water  
692 levels moving up the road toward his house and shed during the event (Figure 23). This notes  
693 suggested that the water crested between 10:00 AM and 12:00 AM on 8/31, which is consistent  
694 with the gauge readings just downstream. Mr. Marthaler indicated that the crest was about 1.0 ft  
695 below what he experienced after Hurricane Georges in 1998, which corresponds exactly with the  
696 crest difference at the USGS gauge.

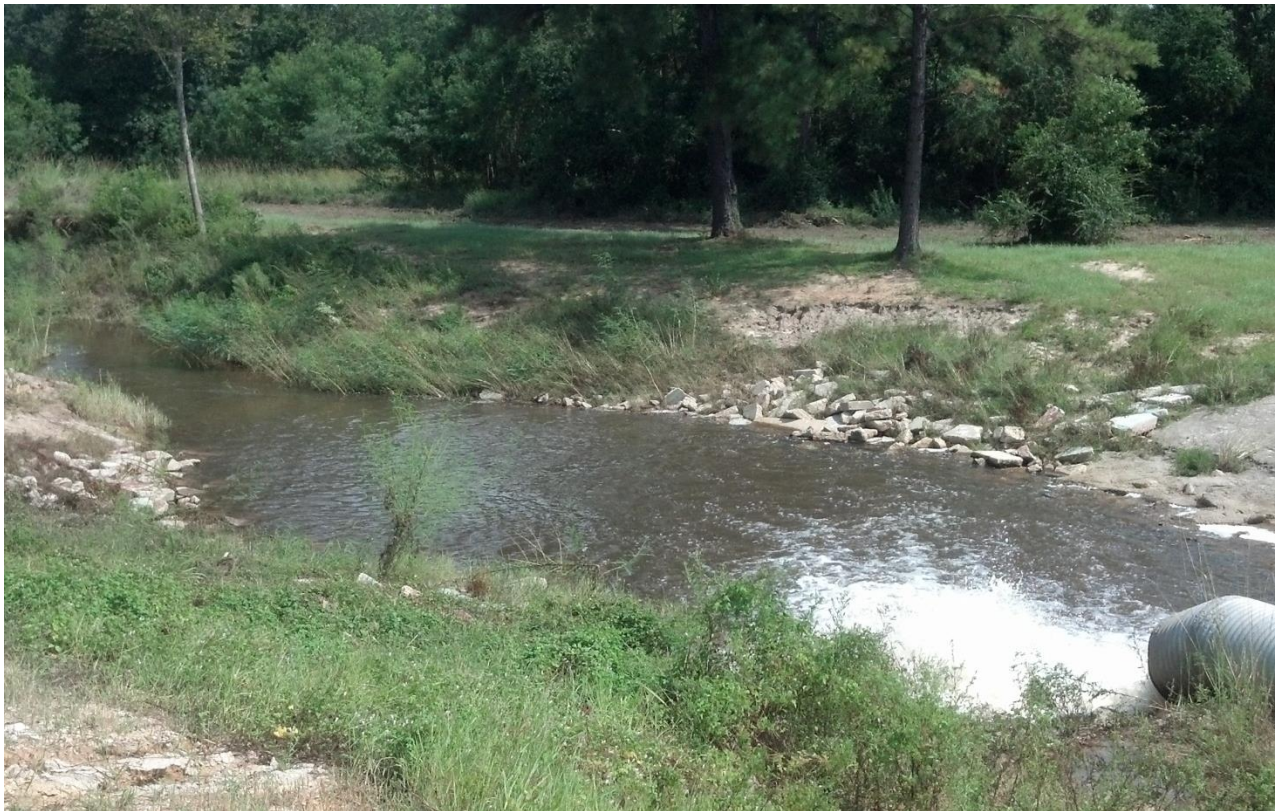
950 Figure 26. Downstream side of Anchor Lake Dam. Trees and brush in the floodplain below the

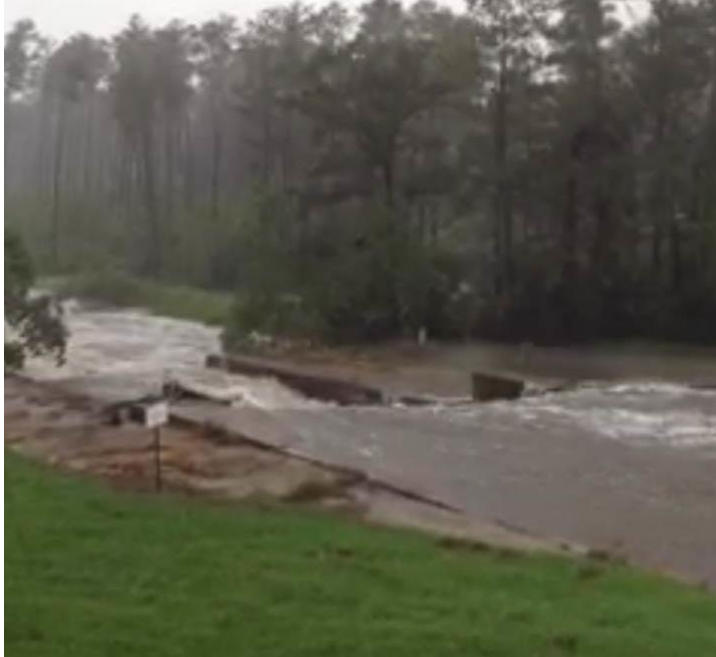
977  
978 Figure 27. Spillway at Lake Hide-a-Way after heavy rainfall from Hurricane Isaac. Image is a  
979 capture from video taken by Bruce Devillier. Lake elevation appears to have reached the top of  
980 the concrete lining the guide channel at the time of the video.  
981

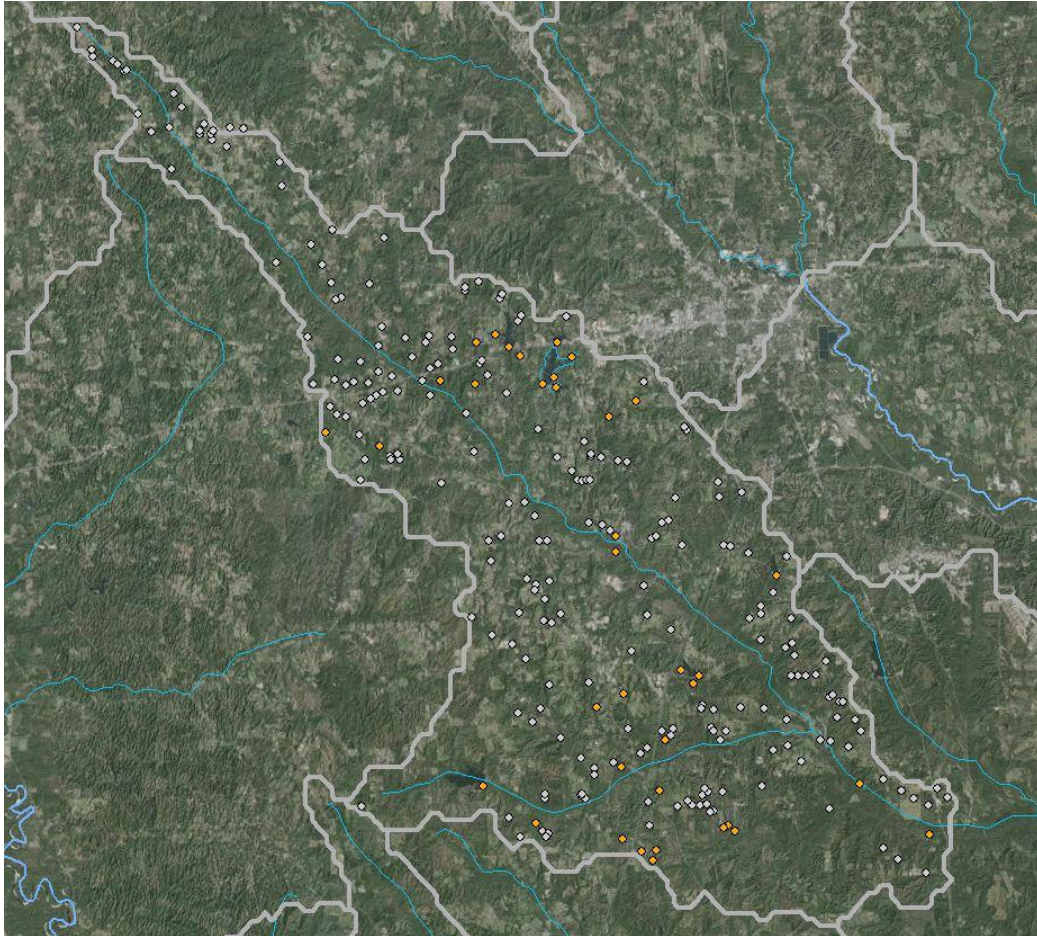
1155 bottom in some locations with unusually clear water for the area. It has been hypothesized that  
1156 land use changes, particularly the slow addition of multiple private retention ponds and small  
1157 lakes, may have changed the response characteristics of the basin enough to mitigate flood risk.  
1158 This remains an area of active research and study, and as such, the hypothesis should be  
1159 considered preliminary at this time.

1160  
1161 Figure 29. Map of the Black Creek at Brooklyn (BKNM6) subbasin with structures showing  
1162 both known dams and unlisted ponds/lakes identified from satellite imagery. Known dams are  
1163 indicated as yellow (37), and manually-added dams are indicated as white (230).  
1164

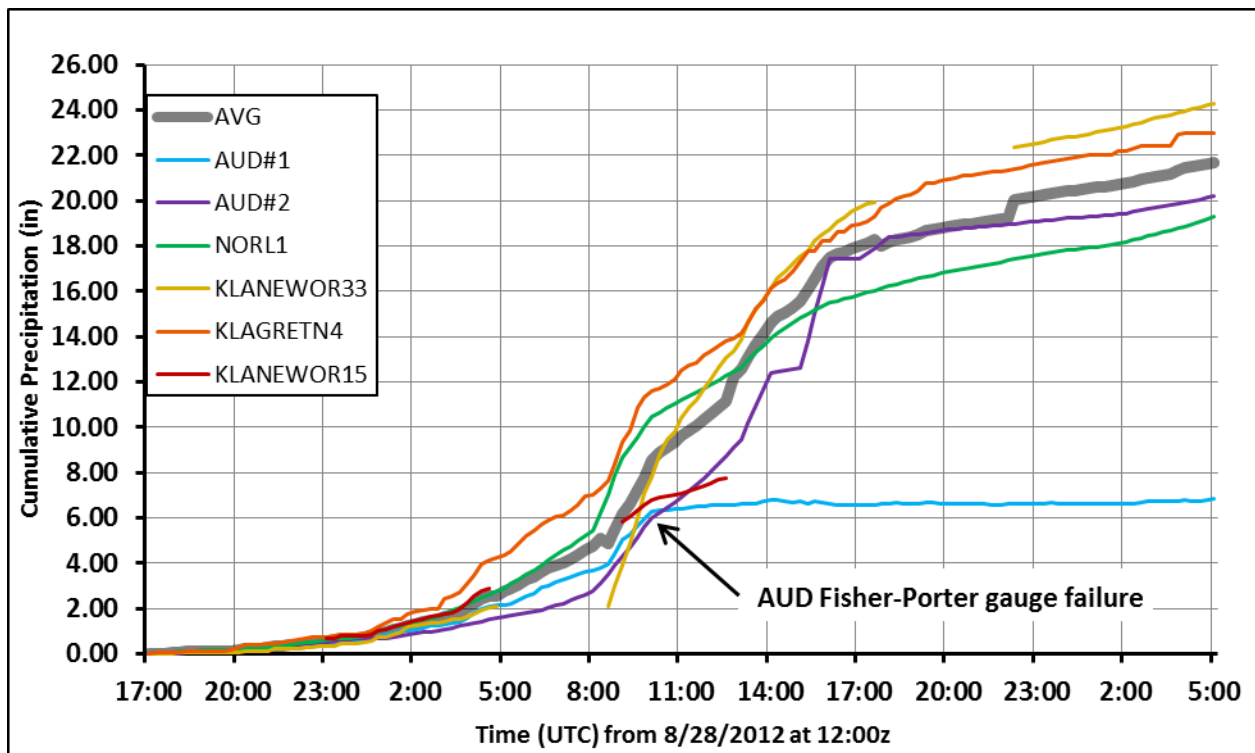
1196 Figure 30. Accumulated precipitation plots for gauges near the Audubon Park cooperative  
1197 observer site. The Fisher-Porter rain gauge (AUD#1) failed after exceeding about 6.0 inches of  
1198 accumulation during the period of heaviest rainfall.  
1199  
1200

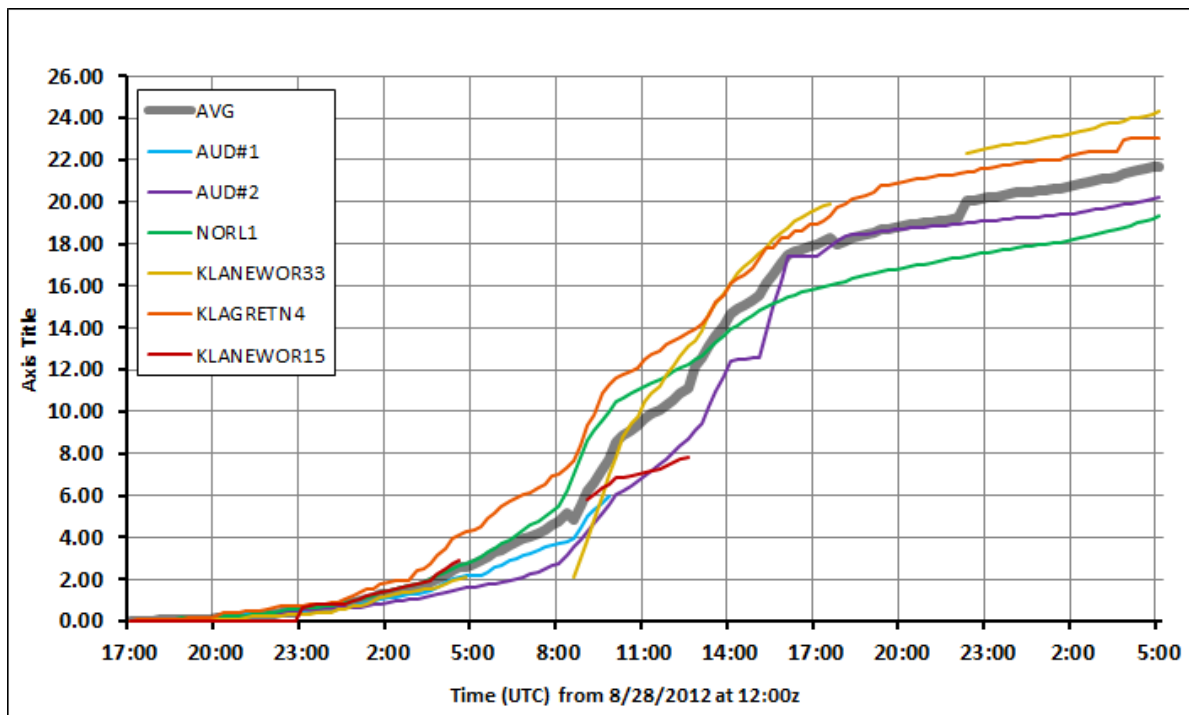
1497 Figure 31. Cumulative rainfall for several official and private gauging sites near Audubon Park  
 1498 in New Orleans. Note the large hourly jump by AUD#2; this hourly value was originally  
 1499 discounted, but in the context of running accumulation seems to have been related to a gauge  
 1500 clog. Also note the substantially lower rainfall rates reported by KLANEWOR15, located 3  
 1501 blocks from AUD – this rain gauge was likely impacted significantly by nearby structures and  
 1502 trees, based upon information from the owner and a site visit by NWS staff.  
 1503

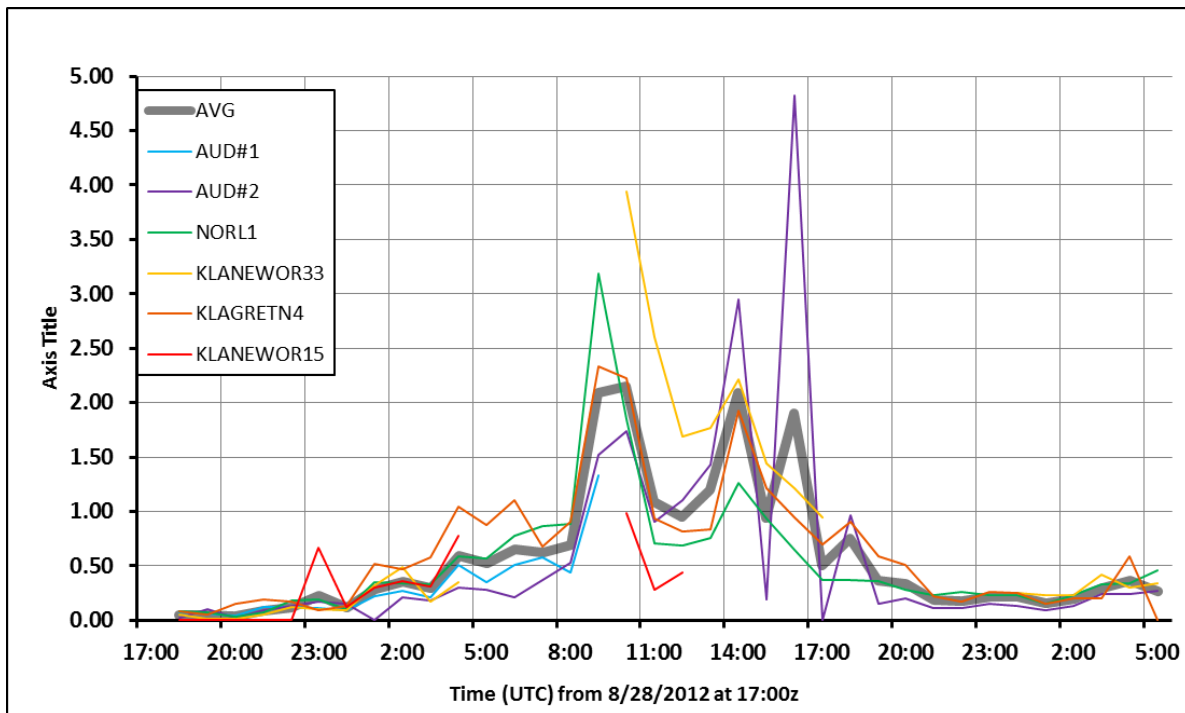
1504  
 1505 Figure 32. Hourly rainfall rates for several official and private gauging sites near Audubon Park  
 1506 in New Orleans. Note the large hourly jump by AUD#2; this hourly value was originally  
 1507 discounted, but in the context of running accumulation seems to have been related to a gauge  
 1508 clog. Also note the substantially lower rainfall rates reported by KLANEWOR15, located 3  
 1509 blocks from AUD – this rain gauge was likely impacted significantly by nearby structures and  
 1510 trees, based upon information from the owner and a site visit by NWS staff.  
 1511

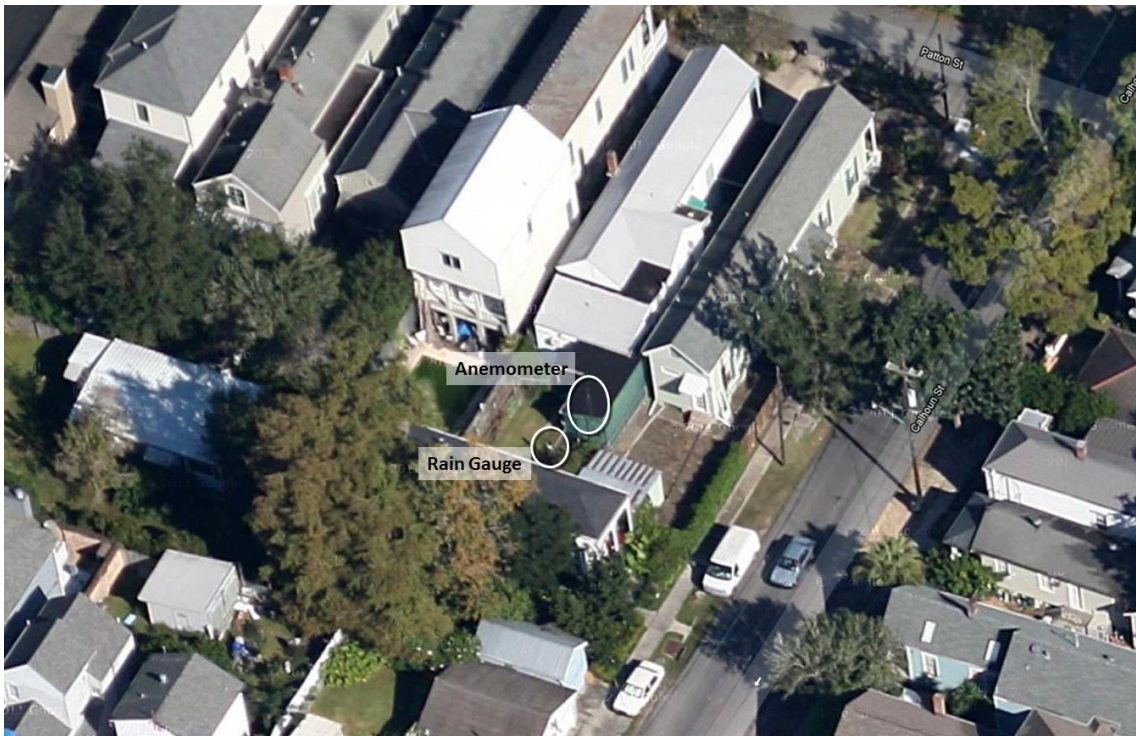
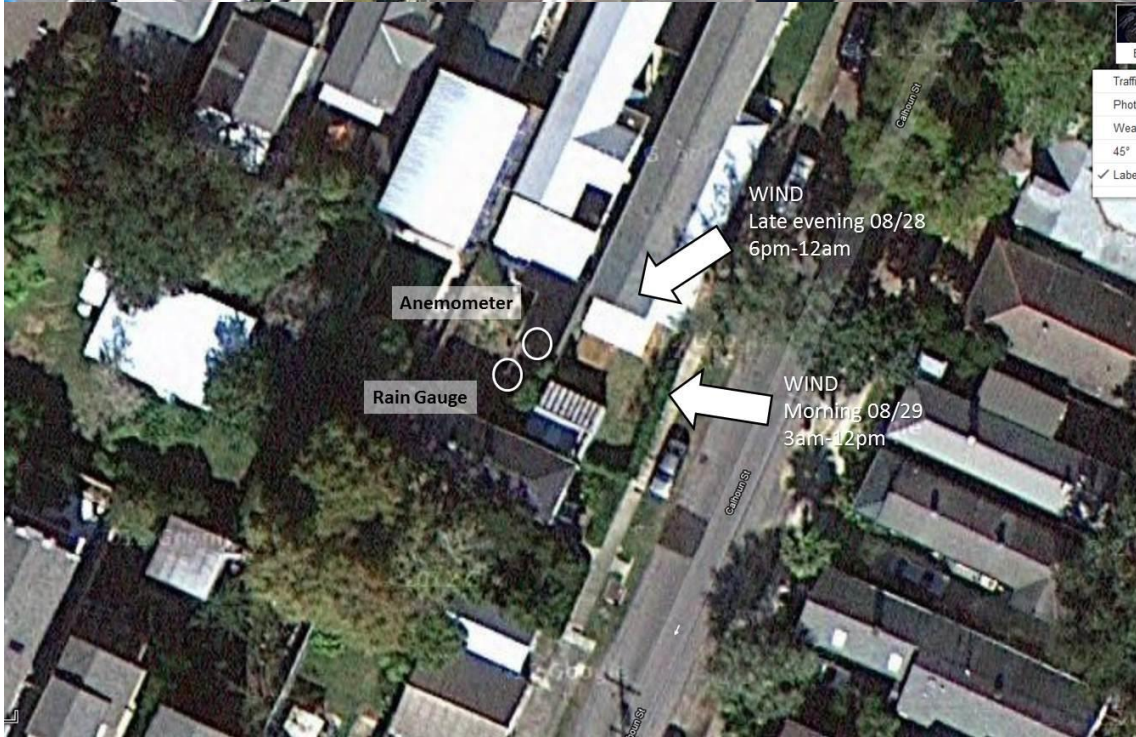
1521 Figure 34. Aerial imagery showing location of Weather Underground PWS site KLANEWOR15  
 1522 in relation to nearby trees and buildings. The predominant wind direction during the heaviest  
 1523 period of rainfall, roughly 3 AM-2PM on August 29<sup>th</sup>, 2012, was from the east, which likely  
 1524 caused an under-estimate.  
 1525

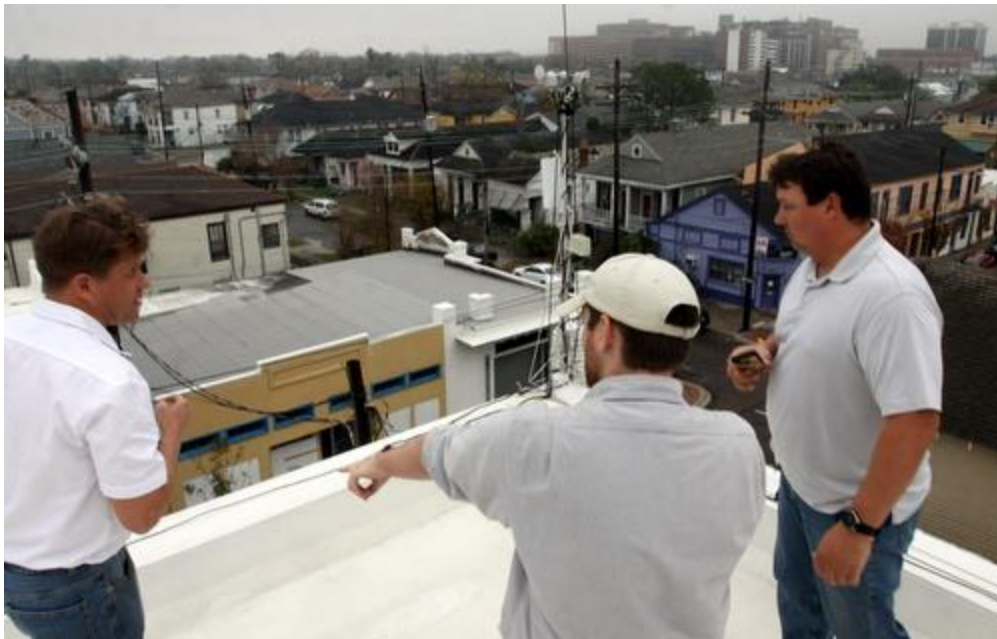
1527 Figure 35. NWS personnel W. Scott Lincoln (pictured, middle), Tim Erickson (pictured, right)  
1528 and Suzanne Van Cooten visited Weather Underground PWS site KLANEWOR33 owned by  
1529 Andy Brott (pictured, left) in January, 2013. The station is located on top of Brott's residence in  
1530 the Uptown Neighborhood of New Orleans. Rain gauge is the box located halfway up the pole  
1531 with the anemometer on top. The station is high above almost all trees and structures in the area.  
1532 Photo credit: Uptown Messenger.

1461 Weather Underground PWS site KLANEWOR33, which reported the highest storm total of 27.4  
1462 inches. Station KLANEWOR33 was located on the roof of a three floor residential structure,  
1463 roughly 30 ft above ground level (Figure 35). The rain gauge was a tipping bucket sensor  
1464 attached to the side of a pole used for the anemometer. The rain gauge and anemometer were  
1465 estimated to be roughly 3 ft and 5 ft above roof level, respectively. The residential structure was  
1466 the tallest building in the neighborhood, greatly limiting the impact of trees and buildings on the  
1467 rainfall measurement. Although the station was sited such that rainfall should not be blocked by  
1468 taller objects, two sources of potential over-estimation were identified. The rain gauge was  
1469 attached to, and within just a few inches of, the pole holding the anemometer. The pole was  
1470 located to the northeast of the rain gauge, which we hypothesize may have provided a
