# **Dust Storm Mitigation**

**New Mexico Department of Transportation  
William Hutchinson & Trent Botkin, Environmental Bureau**

# HSIP-FUNDED DUST MITIGATION THROUGH LANDSCAPE RESTORATION

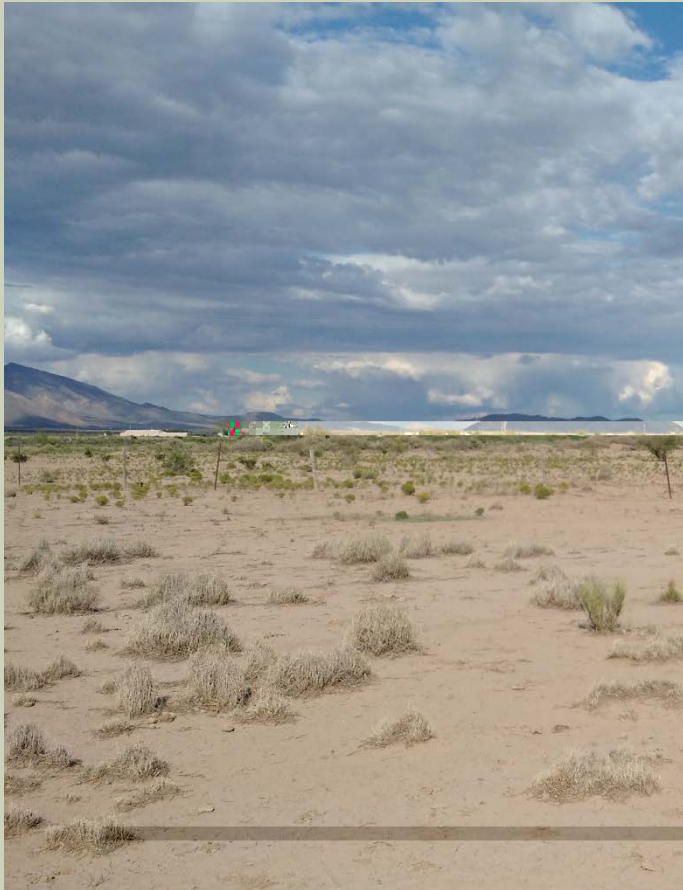
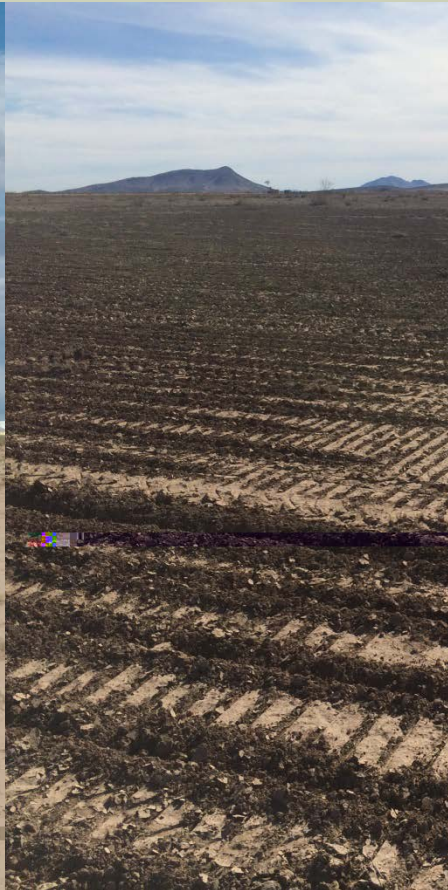
# PHASE 1: US 180 BEFORE, KEYLINED, AFTER

- Keyline (chisel-plow) and reseeding
- Voluntary 4-year grazing deferment on private and SLO land
- Immediate success in halting dust visibility issues

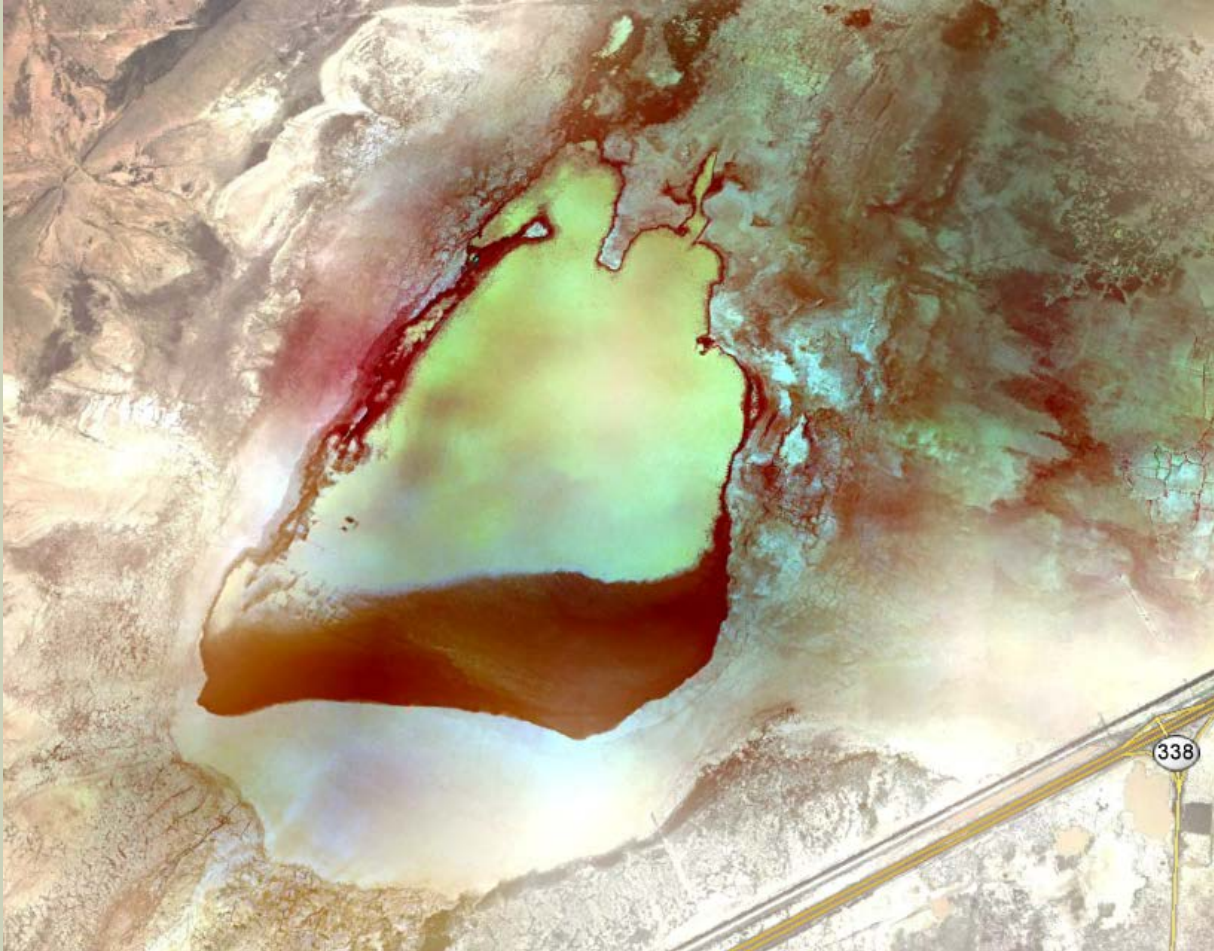
# PLAYA CRUST FORMATION

- Inundation by seasonal rains
- Evaporation forms a hard crust
- Saline, sodic, and biological crusts
