Tornadoes - June 28th 2018

Damage Survey Results from Carter County, MT and Harding County, SD

Summary of Carter County Tornadoes

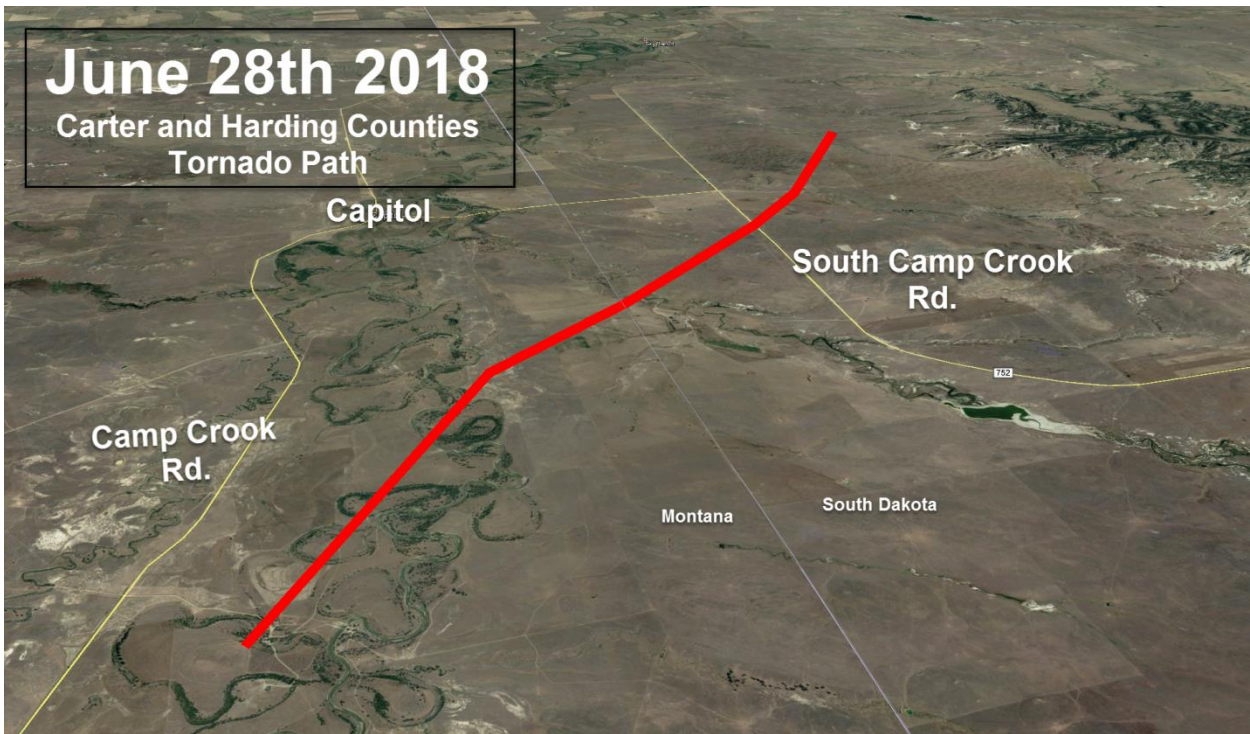
Tornado 1 (EF-0):

Start: 45.3219, -104.4806 (717pm)
End: 45.3548, -104.2803 (735pm)

Tornado on the ground for 10 miles. No damage visible from tornado. EF-0 microburst damage to the south of the tornado due to RFD included; 2 trees uprooted, barn roof blown off, shed destroyed, and a horse trailer flipped over.

Tornado 2 (EF-0):

Start: 45.3503, -104.2066 (744pm)
End 45.3573, -104.1321 (750pm)

Tornado on the ground for 4 miles (6 minutes). Rural areas. No reports of damage.

Tornado 3 (EF-0):

Start/End: 45.3675, -104.0981 (801pm)

Brief touchdown. No reports of damage. Reports indicate anti-cyclonic rotation.

Tornado 4 (EF-2 in MT, EF3 in SD):

Start: 45.3753, -104.0813 (806pm)
 Exit to SD: 45.4092, -104.0406 (820pm)
 End: 45.4475, -103.9904 (830pm)

Tornado on the ground for 7 miles (24 minutes) from south of Capitol, MT northeast into SD.

In MT: 3 mile long path, 200 yards wide. Damage ranged from EF-1 at the initial touchdown, increasing to EF-2 just before the SD border. Large tree limbs down and trees being snapped off, becoming more widespread as the path approached the Little Missouri River.

Max Estimated Wind Speed: 136 mph (EF-3)

Width: Ranged from 200 yards in MT to near 1/2 mile in SD

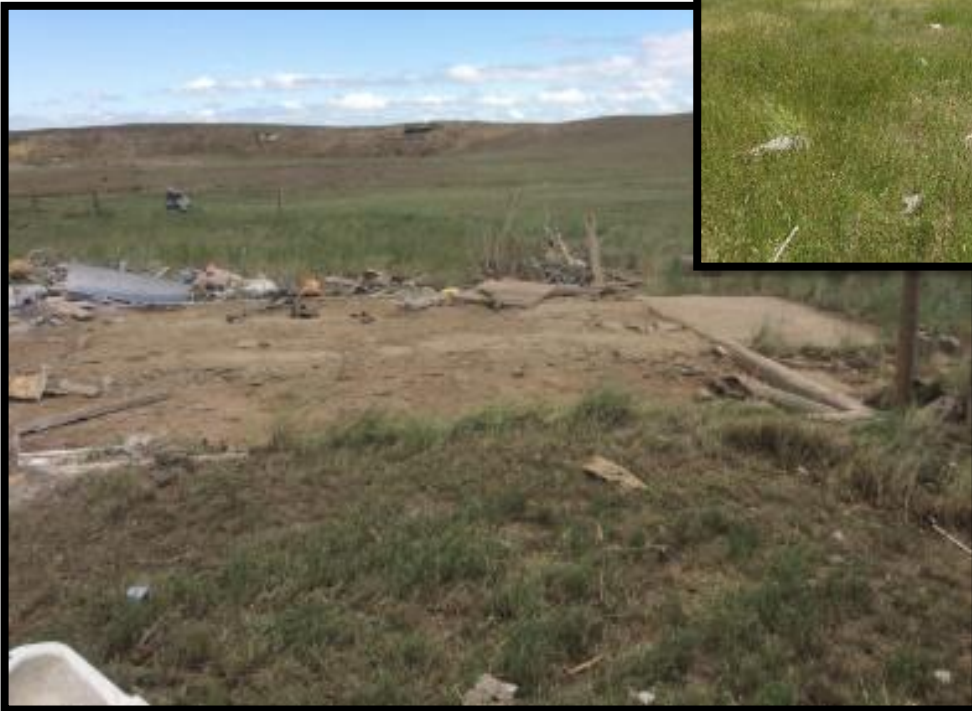
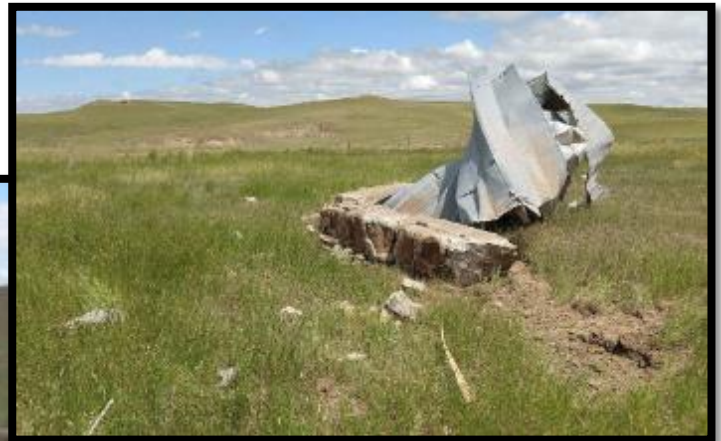
**Photos Courtesy
NWS Rapid City
South of Camp Crook, SD**

In South Dakota, this storm increased to an estimated ½ mile wide and damage observed was consistent with an EF-3 tornado rating, with winds estimated at 136 mph. Preliminary damage in South Dakota included one home destroyed, shed destroyed, trailer toppled over, heavy hay bales moved, along with tree damage (even debarked in some cases). Local residents reported finding numerous dead deer in the debris along the river where the tornado crossed the tree line. Damage in South Dakota is assessed by the National Weather Service in Rapid City and further updates to this information can be found at weather.gov/rapidcity.
