**Alaska - Pacific
River Forecast Center
6930 Sand Lake Road
Anchorage, Alaska 99502-1845
<http://aprfc.arh.noaa.gov>**

**Wind, Rain, Flooding Event across South Central Alaska
October 8-12, 2006**

Prepared by Anchorage Weather Forecast Office and River Forecast Center Staff

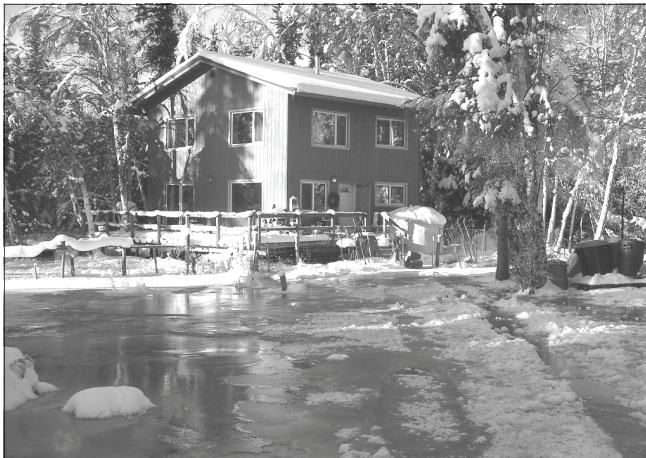
Overflow from Goldstream Creek surrounds a cabin near Fairbanks back in February
Photo taken by Ed Plumb

The cold and dry conditions resulted in considerable overflow icing of creeks and rivers during the winter. There were several reports of overflow inundating private property and causing groundwater levels to rise and dampen some home owners' crawl spaces. The excessive overflow ice has also kept the Department of Transportation busy trying to keep culverts thawed out and water from flowing over roadways. The abundance and thickness of ice on creeks and rivers does have some residents concerned that there may be a higher risk of ice jams during breakup. Fortunately the amount of water in the snowpack is low this year and the amount of runoff into the river systems will be much lower than normal.

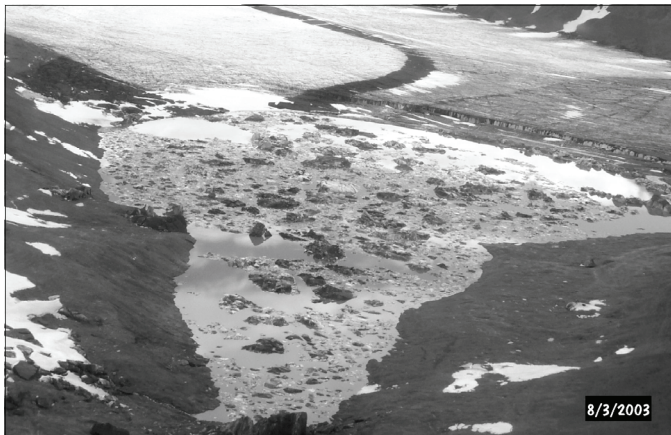
Skilak glacier dammed lake
Photo courtesy of Lyman Nichols

The Skilak glacier dammed lake in the Kenai River basin was expected to release in the fall of 2006, since its previous release was in October of 2004 and the lake typically has a 2 to 3 year filling cycle. When it did not

release, we expected that it would release earlier than normal, but during open water season, in 2007. In open water conditions, the release of the Skilak glacier dammed lake typically causes a rise of several feet, but usually occurs in the fall when water levels are low, and thus is not a significant flood threat. In mid January an otherwise unexplained rise in river levels was indicated by the stream gages and was confirmed by river observers. The

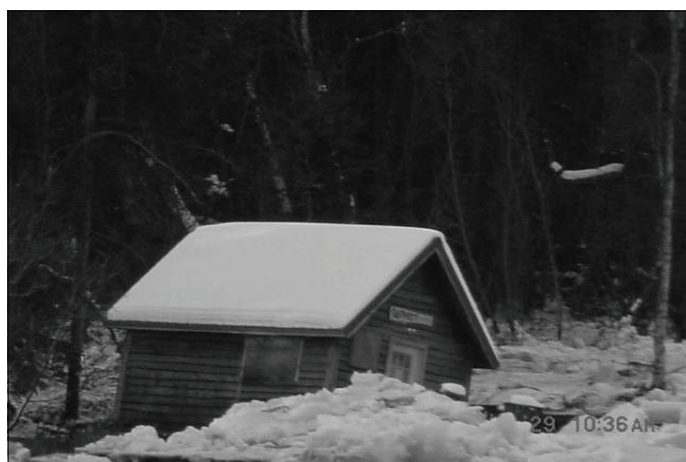
Damaged cabin on the Kenai River
Photo courtesy of Kenai Peninsula Borough

water level rise due to the release this winter was sufficient to break up the ice and cause ice jams. The peak water level at the Soldotna gage was 2.6 ft below the 1969 levels, but significant damage was still done to streamside structures such as fishing platforms, docks, and stairways. (The highest stage in 42 years of record at the Soldotna river gage was due to the release of Skilak glacier dammed lake in January of 1969, when the Kenai had an ice cover, and ice jams caused the high stages and significant damage.)

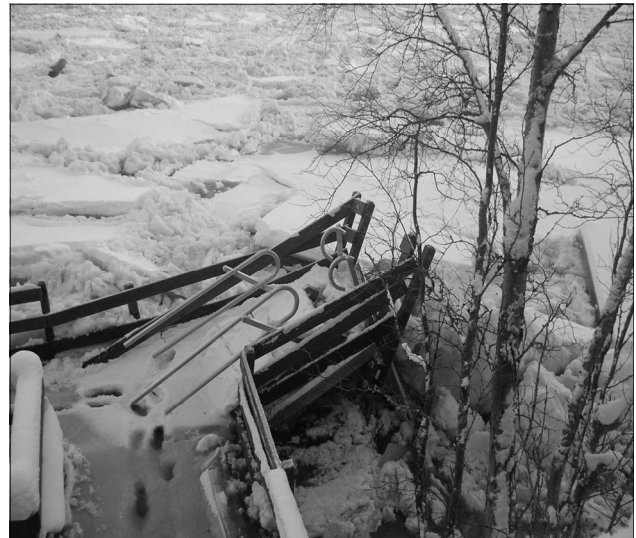
Damaged stairway at the Kenai River Center
Photo courtesy of Kenai Peninsula Borough

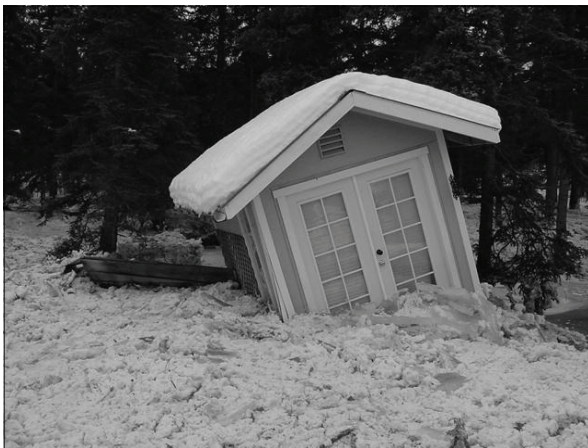
Damage to an outbuilding caused by the release of the Tazlina West glacier dammed lake
Photo courtesy of local resident

residents. The resulting ice breakup caused extensive flooding, with ice reportedly reaching nearly to the underside of the Richardson Highway bridge. Some homes along the river reported water up to the interior electric wall sockets. Besides inundation of an unknown number of homes, numerous cars, snow machines, and outbuildings were damaged or destroyed by ice. There

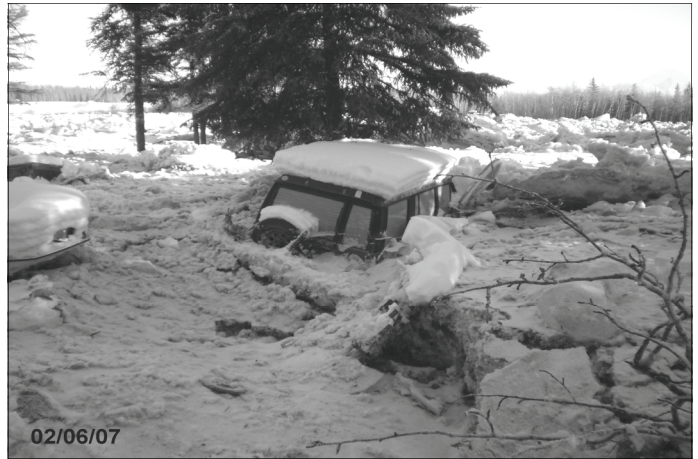
Car surrounded by ice following the release of Tazlina West glacier dammed lake
Photo courtesy of local resident

is insufficient information to know if the ice formed an ice jam downstream of the bridge or if the breakup front continued to move downstream at a rate that caused significant backwater behind the front, but the front moved far enough on Sunday that the river fell below flood stage by Sunday morning between 9:00 and 11:00. Significant amounts of river ice, with pieces up to 3-4 feet thick, remain in the formerly inundated areas.
